Floods in Germany (June 2013)

Post-flood field investigation, July 2&3, 2013 Preliminary Findings

Bas Jonkman, Timo Schweckendiek, Guy Dupuits (TU Delft); Torsten Heyer (TU Dresden); Joop de Bijl (STOWA); Astrid Labrujere (RWS)

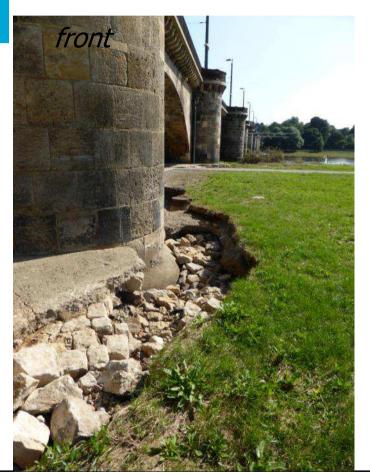
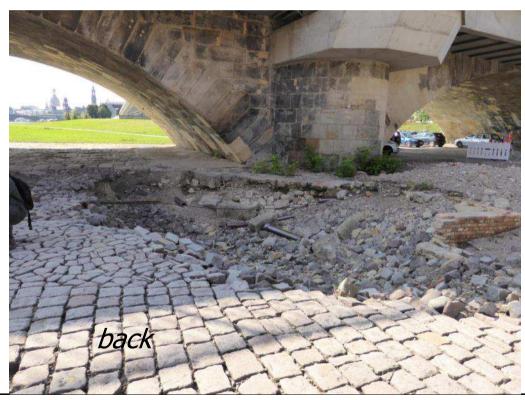
Dresden – erosion

unexpected erosion next to the Marienbrücke in the bypass (after removing obstacles downstream)

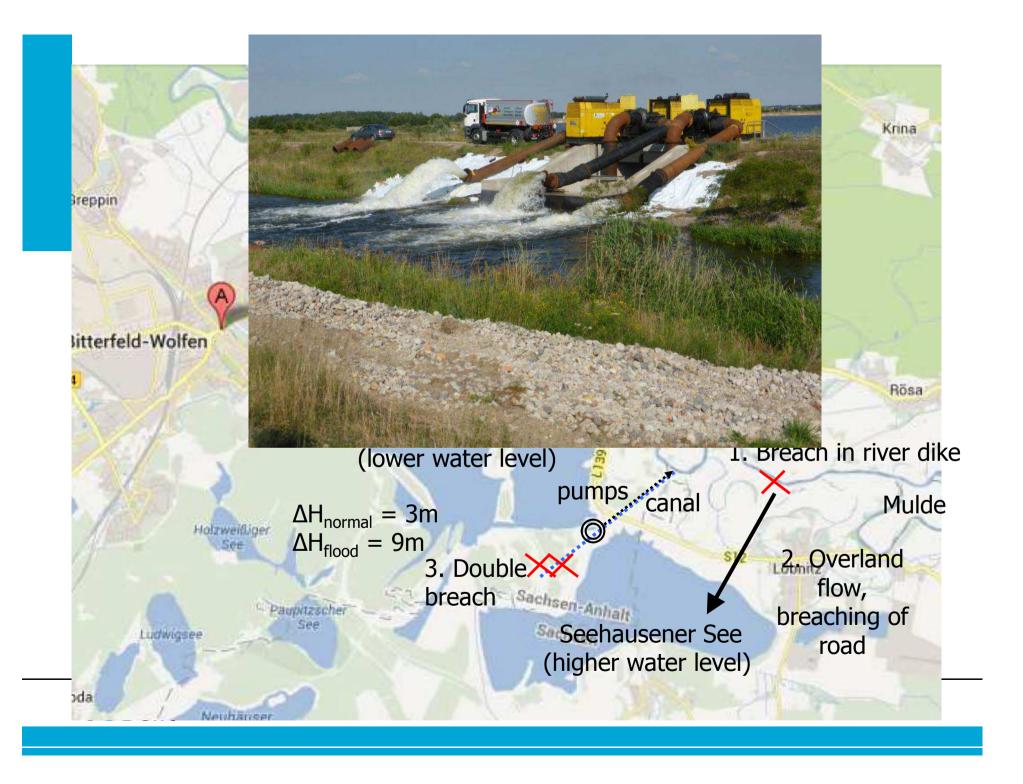
1. Bitterfeld – Mulde breach

- Breach on the Mulde river, one of multiple breaches
- 25 m wide breach, relatively high on slope
- Wells on the inside of sandy material, possibility of piping mechanism
- Highest water about 1m (?) below crest

- Next to small dewatering structure and small pond
- In 2002 a breach occurred in the same area, a few hundred meters upstream from the current breach.

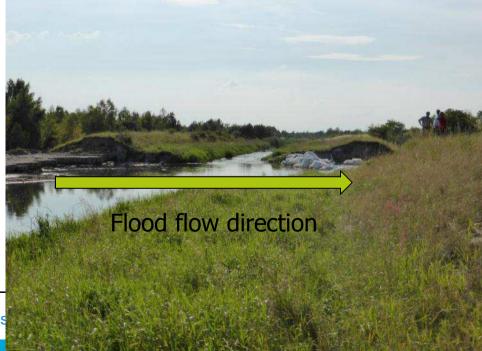
Bitterfeld – dewatering

Breaches created with dynamite for dewatering

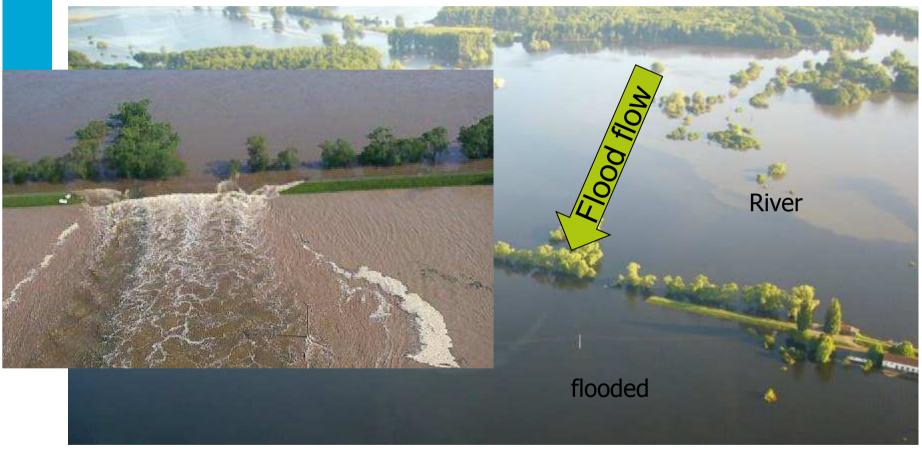
Breitenhagen - levee breach

- Located on Elbe river, water levels about 1~1.5m below crest
- Trees located in front of dike
- Dikes consisted of clay, slope about 1:2.5 to 1:3
- Slip circle occurred on inside, on landside of the road
 - Part of the dike remained for 10 hrs, then breached
 - 150m breach
- Dike reinforcement plan was available, but not yet implemented
- Emergency measures:
 - First round of bigbags delivered by helicopters
 - After that no army assistance available anymore
 - For dewatering:
 - Explosions were not effective to blow up dike
 - Breach opened by equipment for dewatering
 - Pumps installed to dewater the urban area

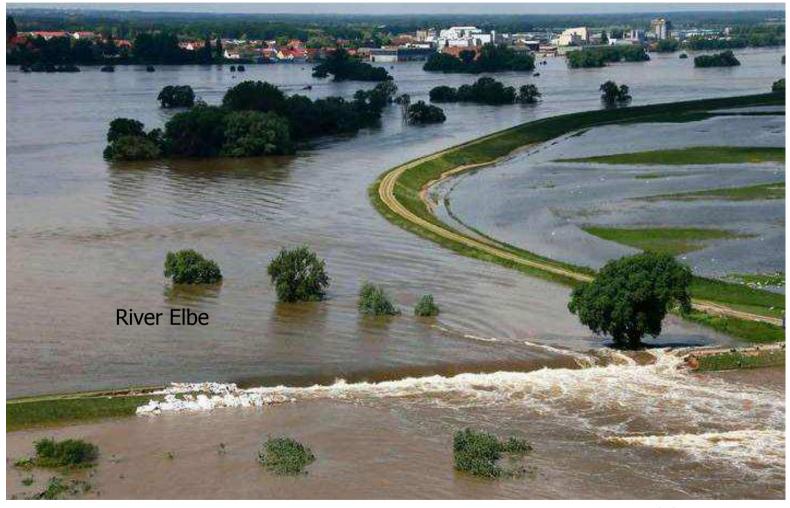
Fischbeck (levee breach)

- breach location located at "corner"
- Western side of the Elbe,
- water level below crest (0.2m ~ 0.4m)
- dike: about 5m high, moderate/steep slope (about 1:3?), no berm
- dike body: clayey sand (sandy clay in lower part)

- cracks in crown, stage-wise settlement of the inner slope
- heavy flood fighting to prevent breach (sand bags, big packs)
- breach occurred around midnight (Sunday 9 June around 00:01 AM)
- inner slope sliding/breach occurred fast (10 ~ 20s)
- initial width 50m, growth to 100m within hours, 2-3m deep scour hole
- estimated inflow up to 700-1000 m³/s (different figures in BfG report)
- Water was within town of Fischbeck (~ 2km) within 5 minutes
- Fischbeck had been evacuated previously
- flooding extended in a wide area (up to the Havel river, tens of km)

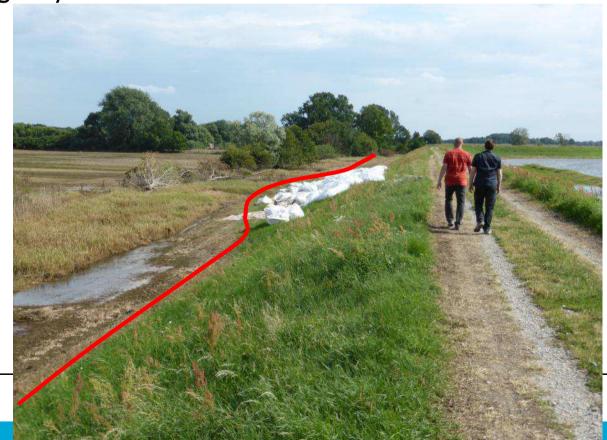
Fischbeck - local instability

- Few hundred meter from breach site
- Seems initiation of slip circle over about 25 ~ 30m
- Sheet pile in dike and bigbags on slope implemented as emergency measures
