ESD-related damage mechanisms in microelectronic devices

Peter Jacob

Overview about ESD damages caused by process robotics

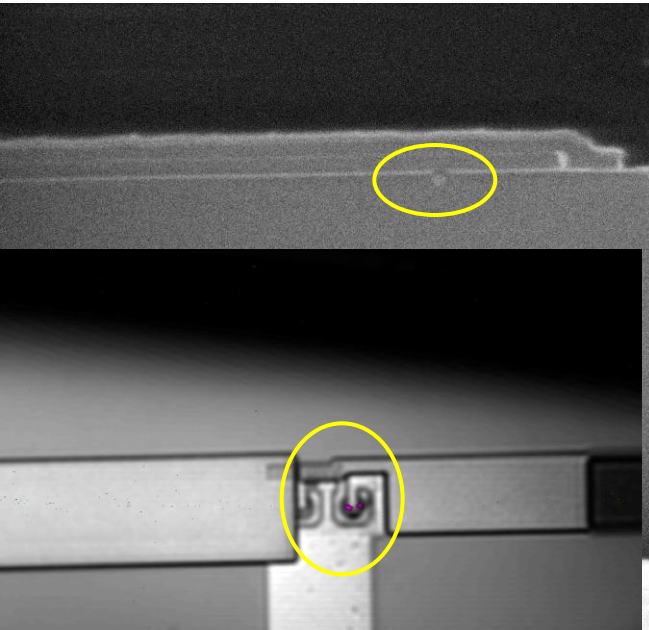
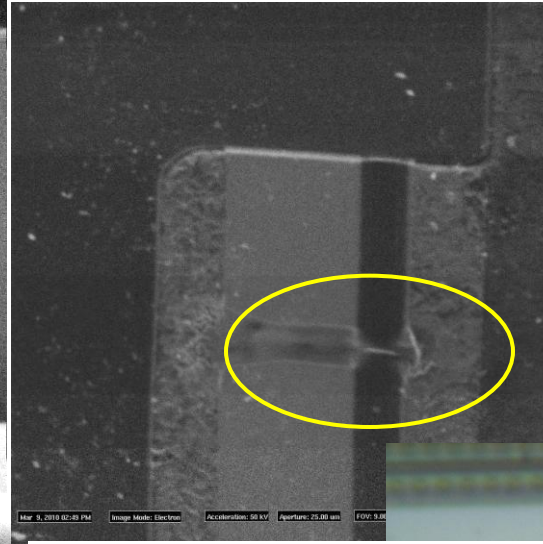
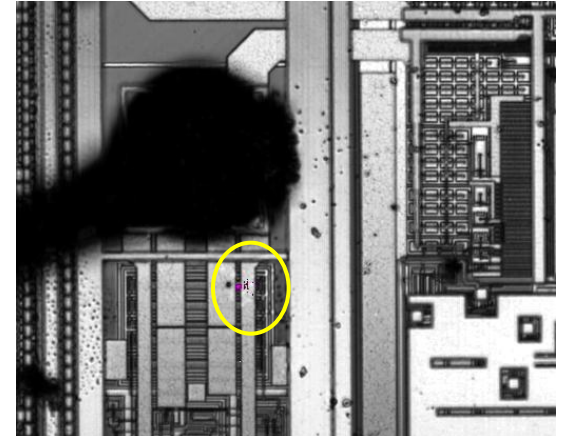
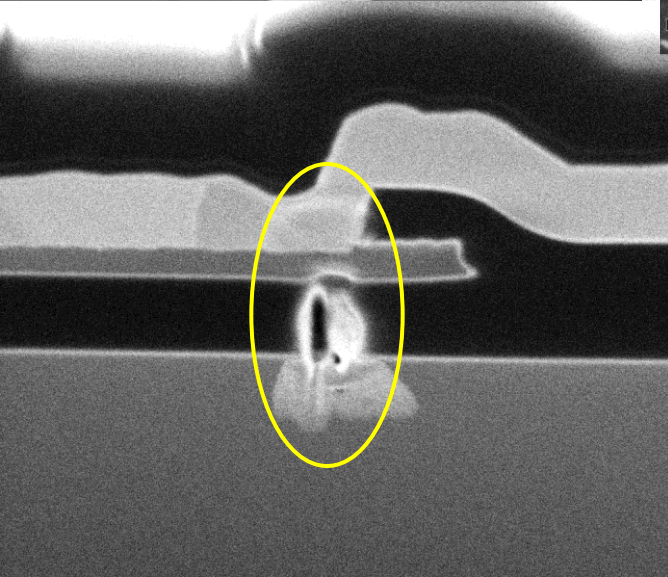
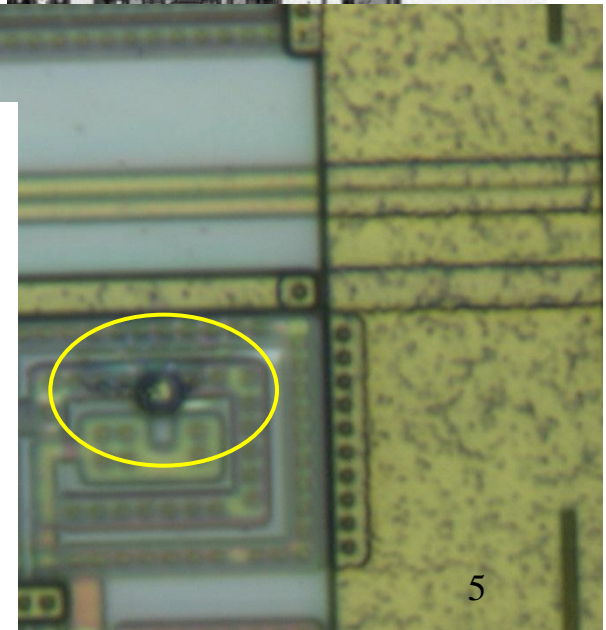
Examples for pin-pathed ESD-damages...

...from hardly detectable p/n leakage to EOS-like breakdowns, frequently assigned by secondary damages, like for instance fused metal lines

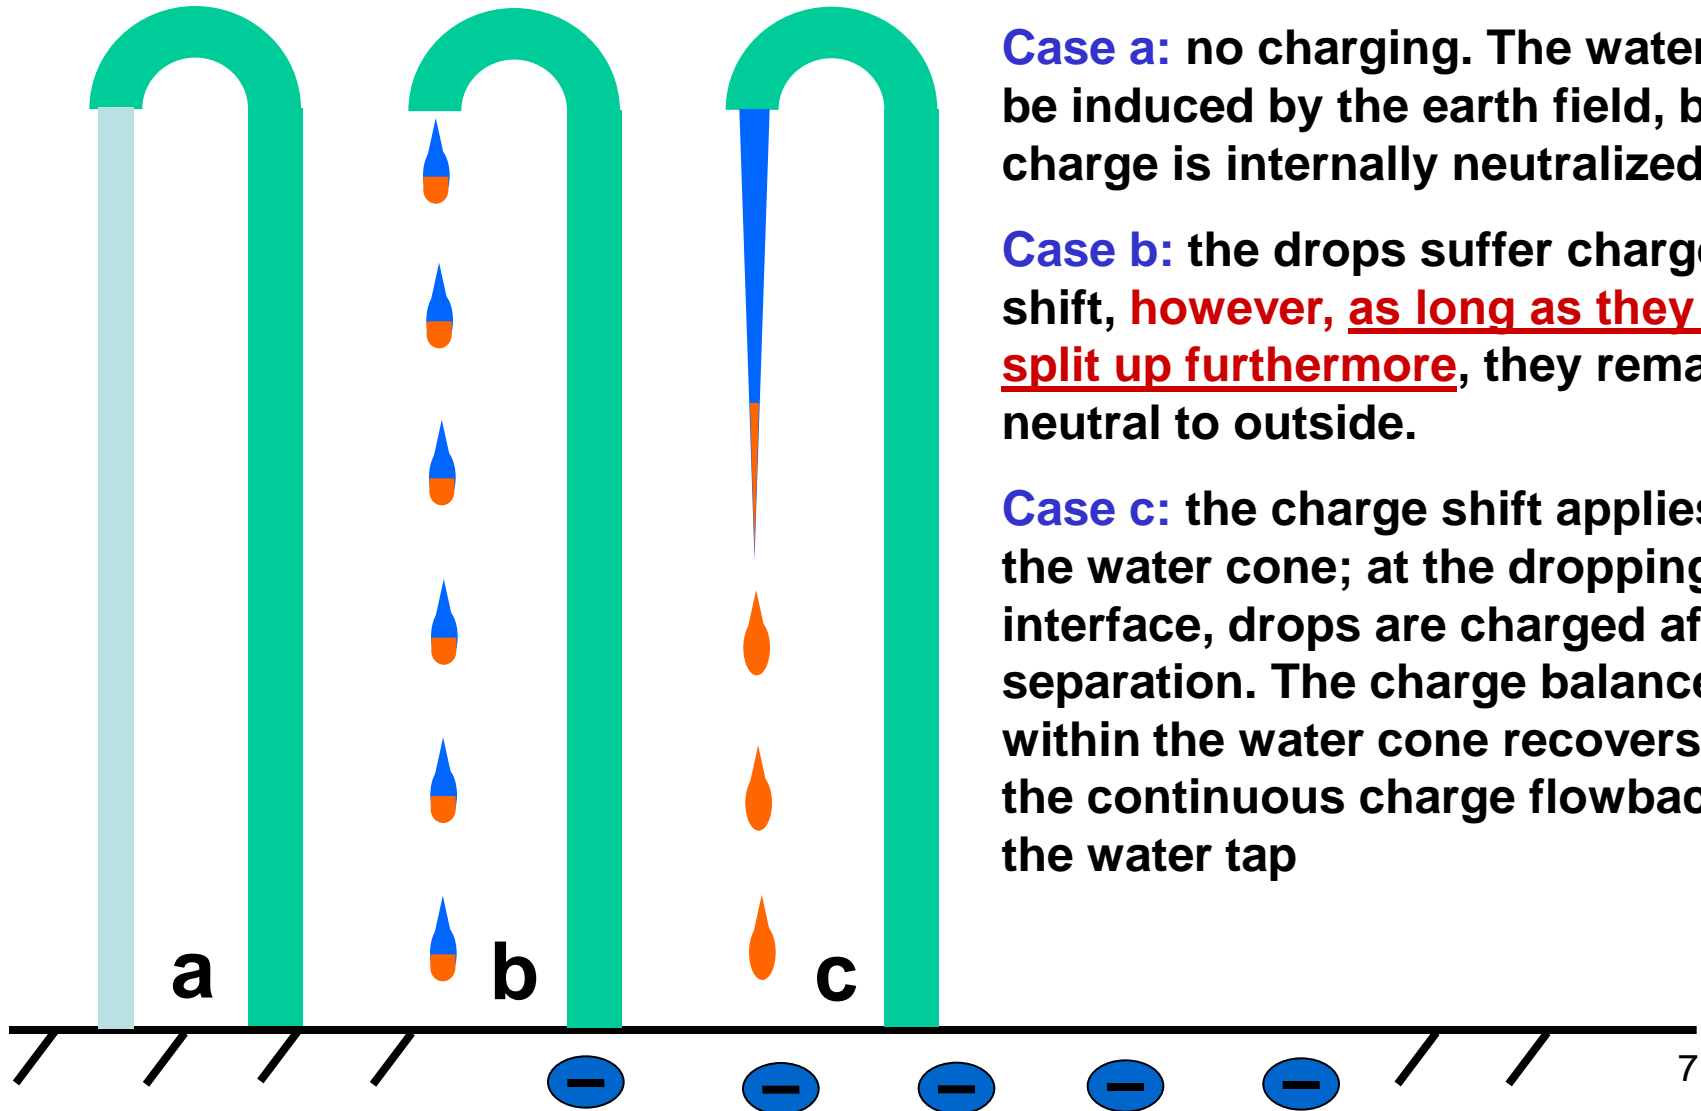
Wafer Sawing: Charge separation in water drops

Case a: no charging. The water will be induced by the earth field, but the charge is internally neutralized.

Case b: the drops suffer charge shift, **however, as long as they don't split up furthermore**, they remain neutral to outside.

Case c: the charge shift applies to the water cone; at the dropping interface, drops are charged after separation. The charge balance within the water cone recovers by the continuous charge flowback into the water tap

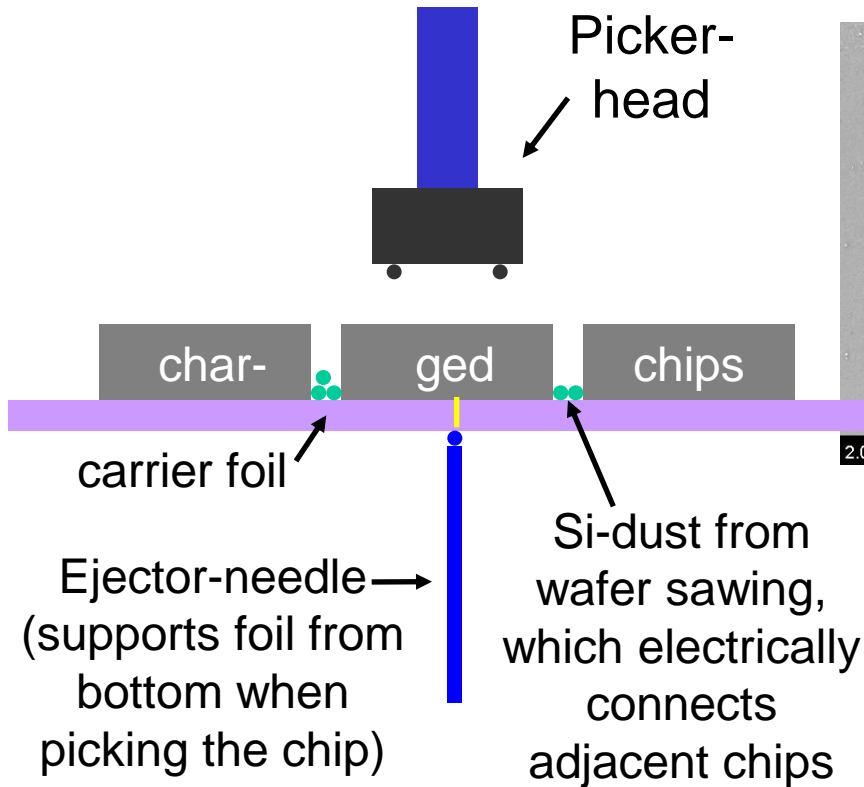
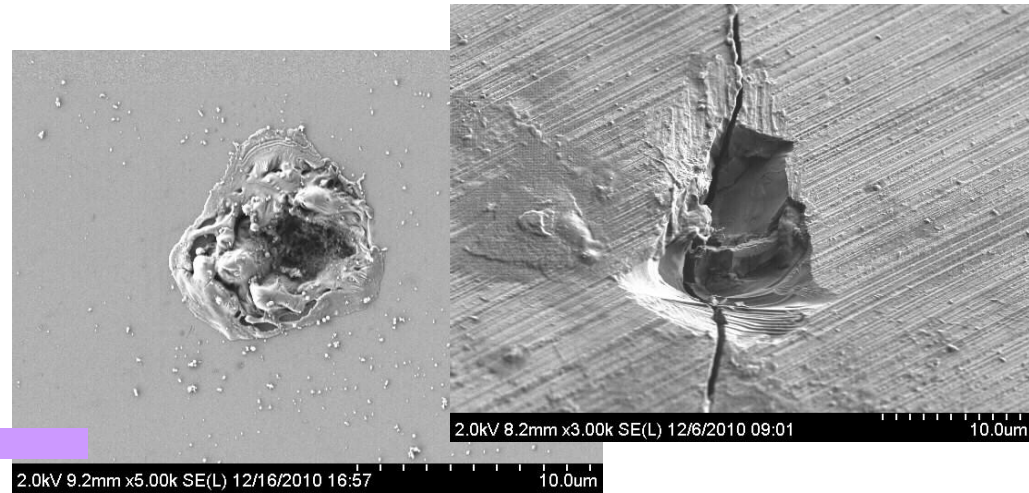
ESD-impacts from the backside when picking chips from the blue carrier foil

comparison ESD (left) vs. mechanical (right)

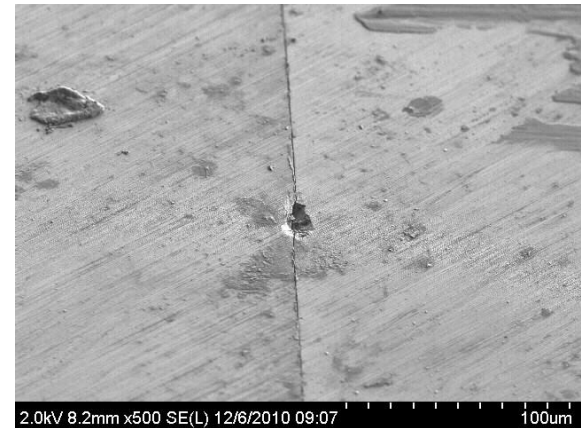
In case of severe damaging, potential bulk crystal damage is generated. Later this may result in die-cracks

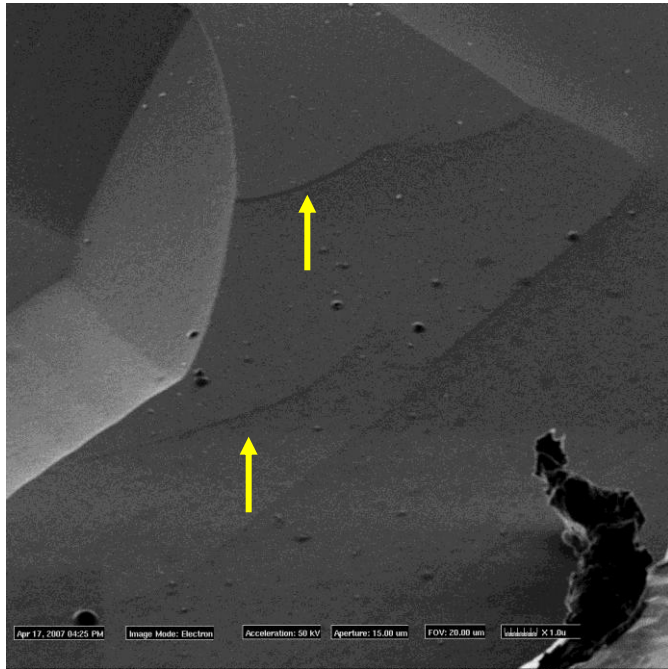
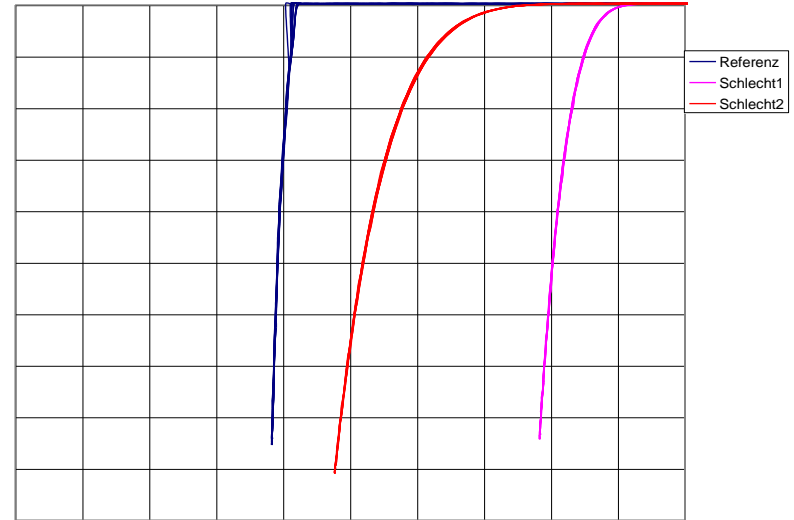
ESD damage on LEDs

It is hardly known that LEDs are very ESD sensitive. If overvoltage spikes are applied in reverse bias direction, point- or line-shaped low-current leakage paths are generated. However, since they have a high current density, they start to extend soon. Since they are superimposed in the forward direction by the low-voltage operational IV-characteristics, they remain without attracting attention at first. However, they shorten the LED lifetime significantly in by-the-time formation of dark lines and dark spots, thus reducing the emitted light.

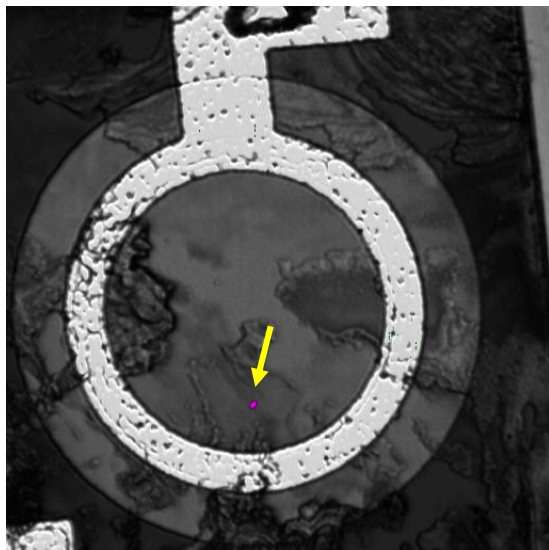
Degradation of a leakage path of a LED

OBIRCH RBL-localisation (reverse direction)

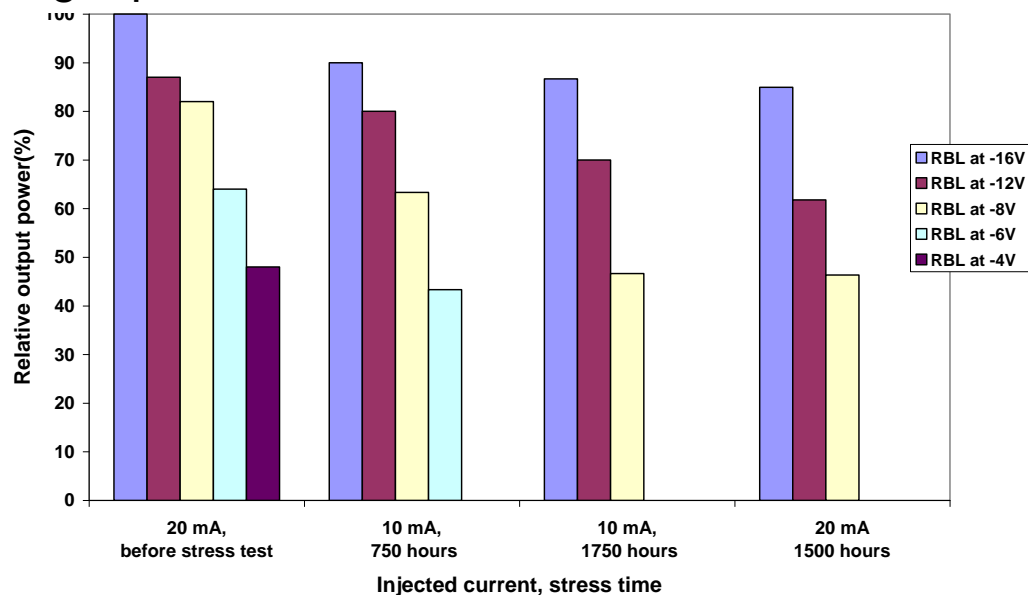
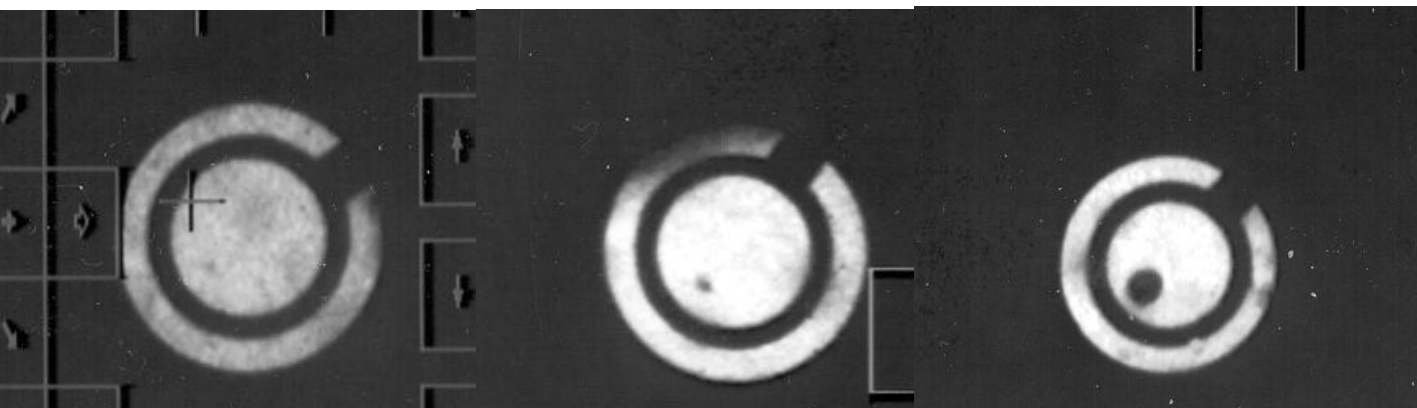
Emitted light power reduction of LEDs with different RBL

Forward operation: missing light emission in the leakage spot (dark spot). It increases and thus, the total emitted power decreases

ESD on LEDs doesn't stop function, but reduces their lifetime!

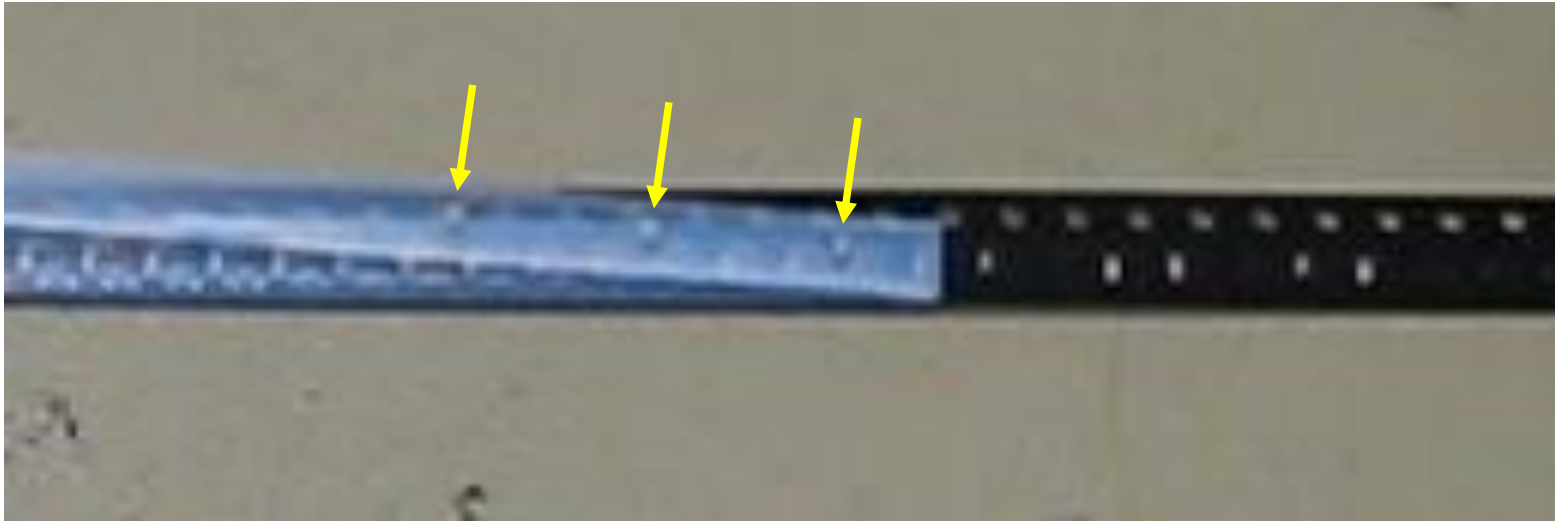
Obstructions in the process sequence by electrostatic charging in insertion machines

When pulling-off the deck tape slowly (here demonstrated manually to have a better access for photography) non-antistatic material will cause electrostatic charging. The resulting electrostatic adhesion fixes small devices partially at the deck tape, thus significantly disrupting the mounting- or placement process, here demonstrated at the example of small SMD-LEDs.

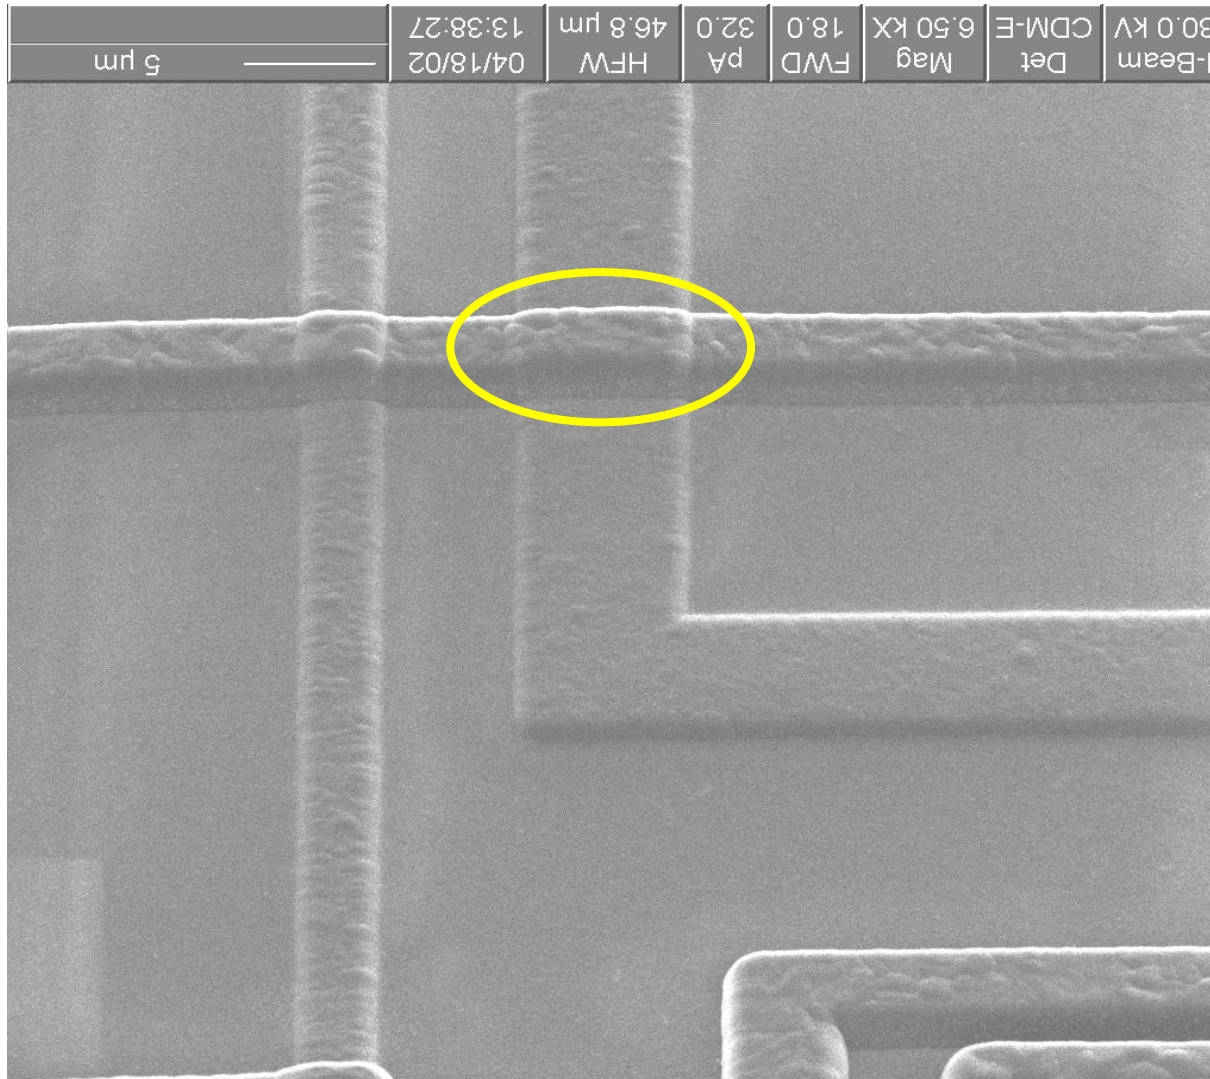
Nearly invisible ESDFOS

A small crack, hardly visible in an optical microscope, nearly invisible by FIB or SEM, indicates the impact

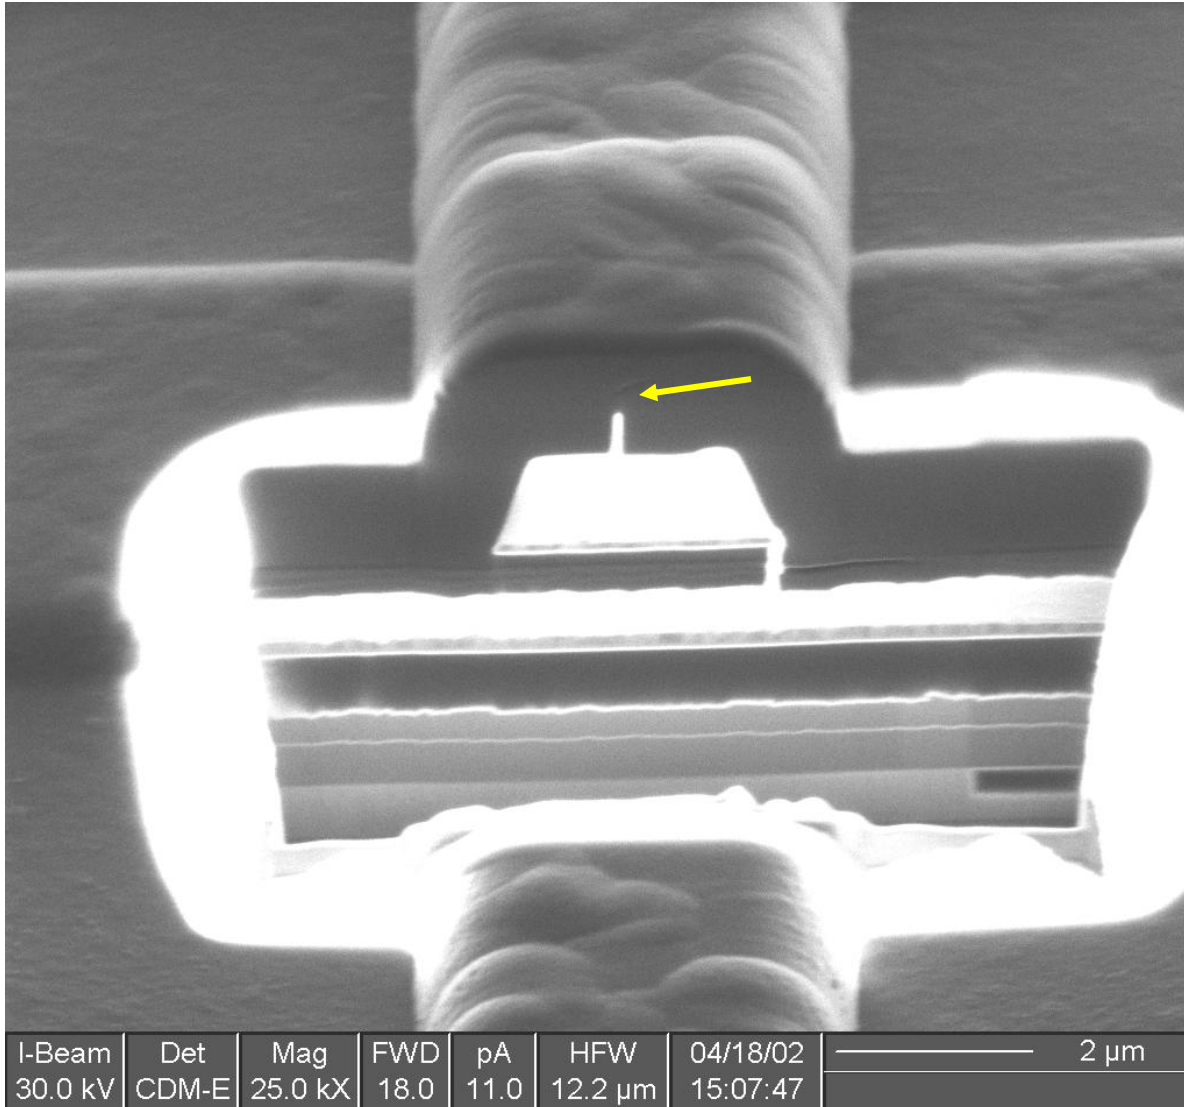
FIB-Cross Section of this ESDFOS

FIB CS: M1-M2
filament
interconnect.
Small needle
peaks (arrow)
indicate the ESD-
related cause of
the problem

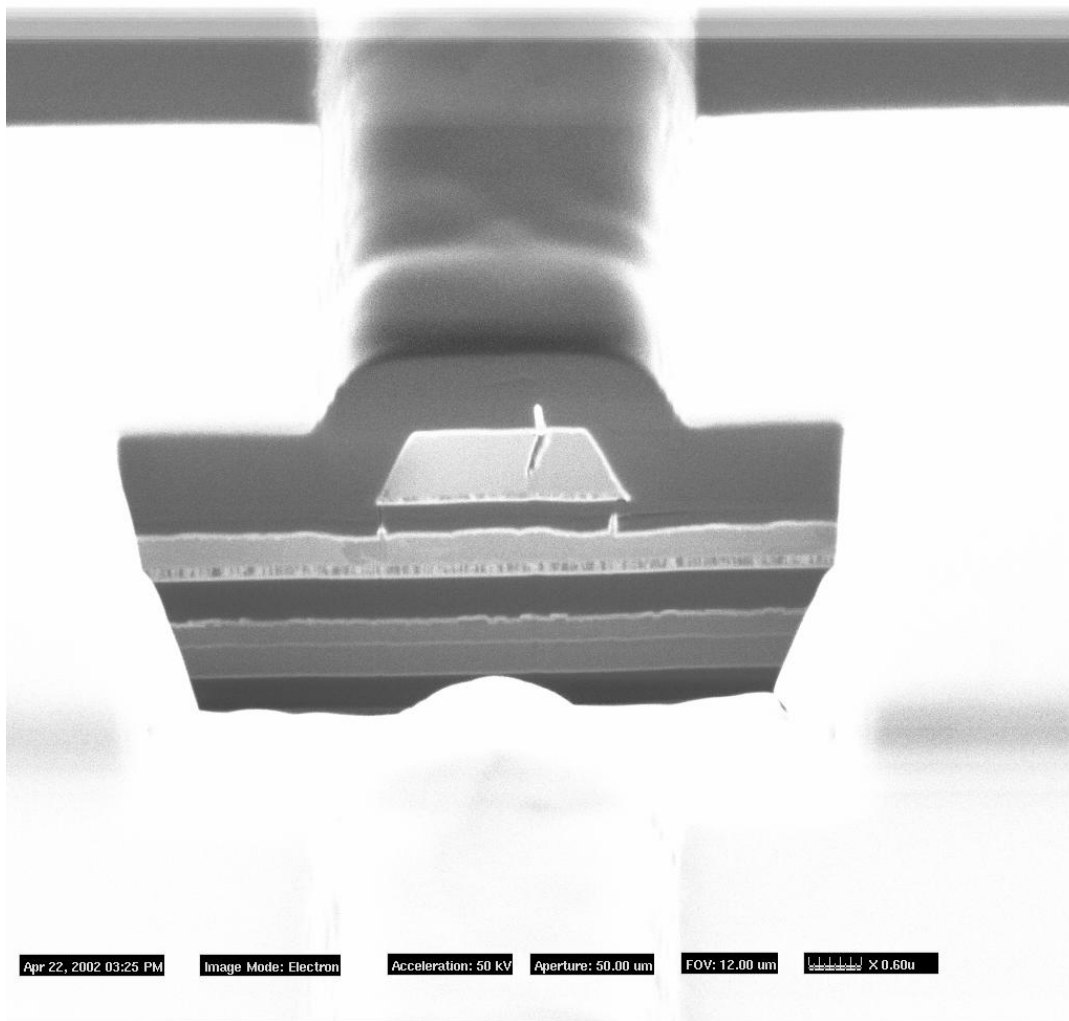
Reliability: Latent ESDFOS

Reference device,
elektrically good,
next device on
tape, neighboured
to a bad one.
„Blind“ FIB-cut at
the same position:
Latent ESDFOS
failure

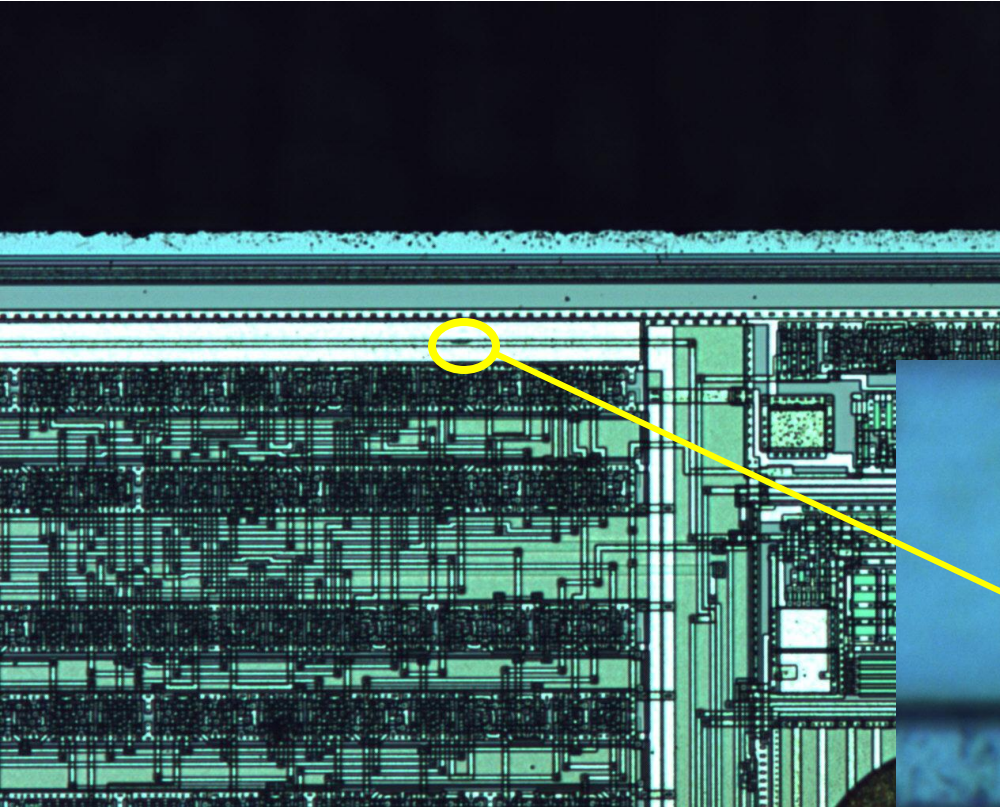
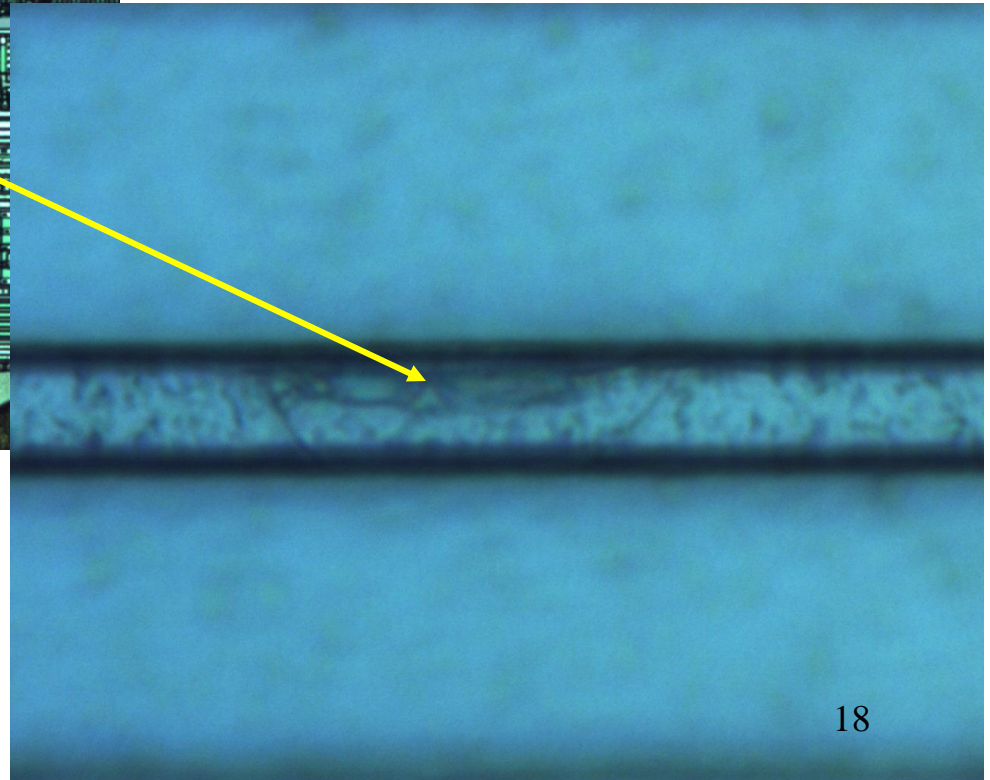
Chip border ESDFOS

**ESDFOS main root causes:
Frontside wafer detaping, wafer
dicing, wafer separation after
laser dicing, pick&place, framed-
wafer lifting from chuck, then
loading into cassettes**

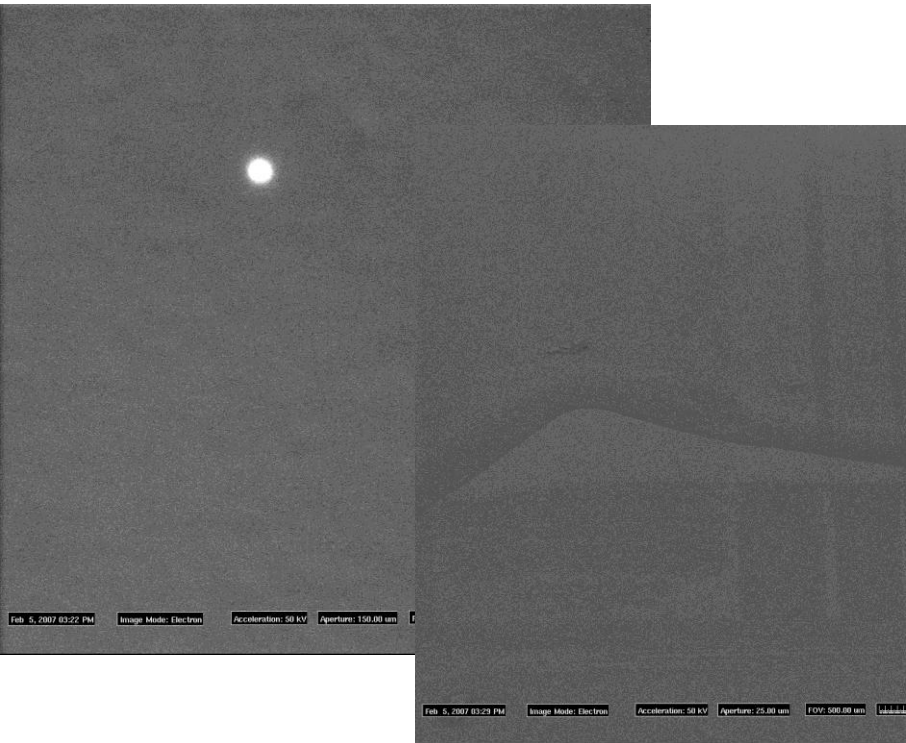
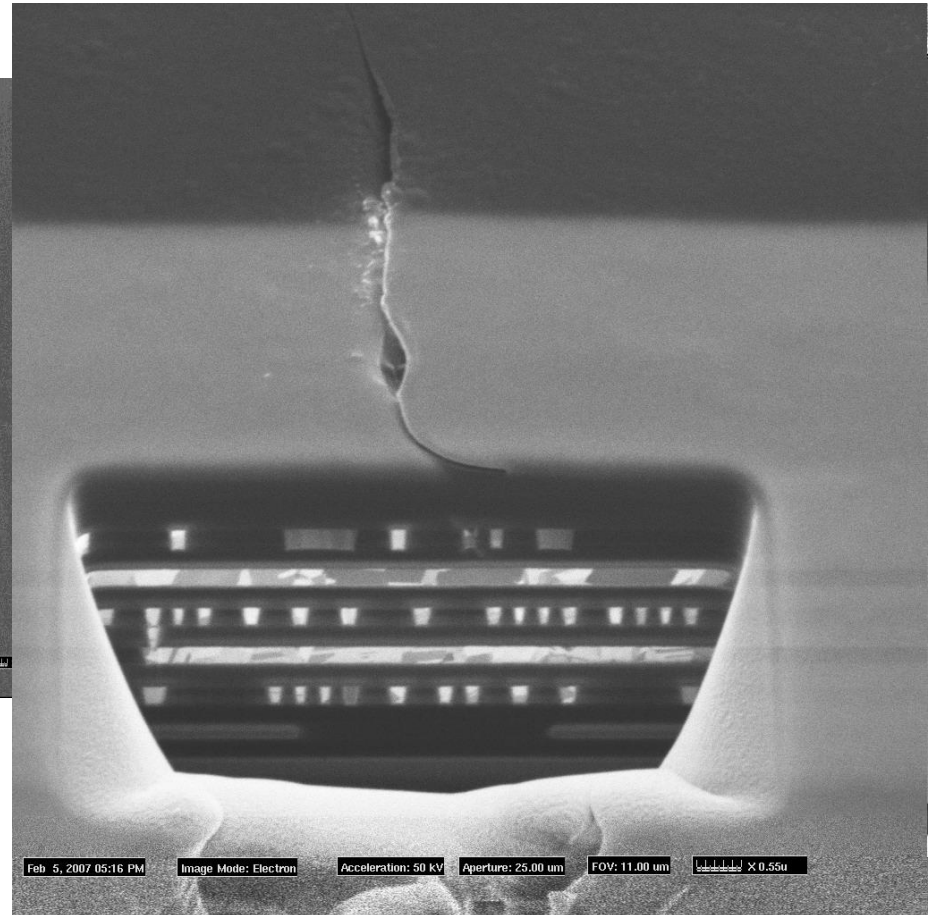
ESDFOS in planarized Cu-metal technologies: Low degree of severity

**very small cracks, strong horizontally oriented, partially
without functional damage**

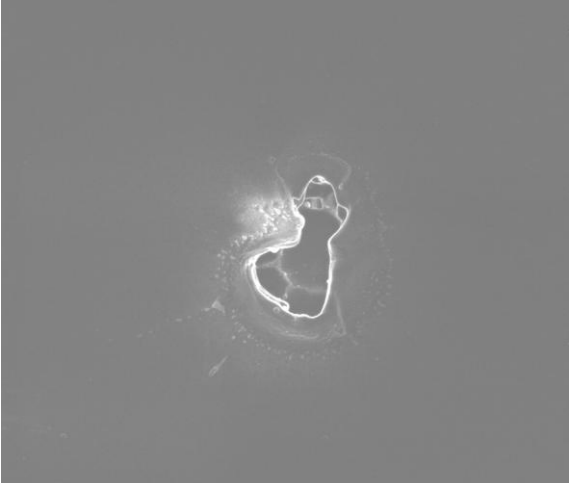
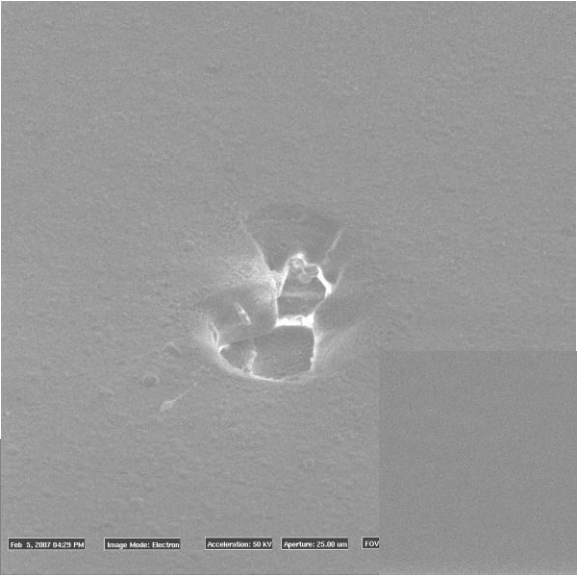
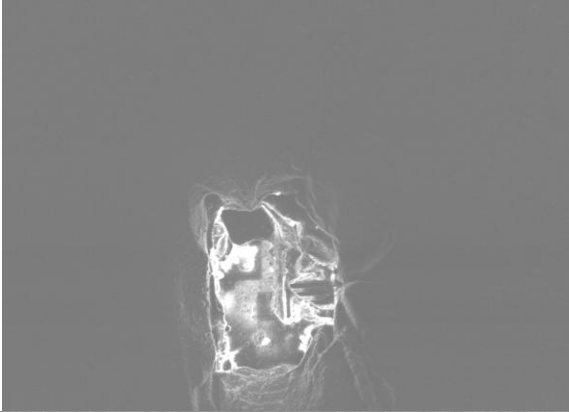
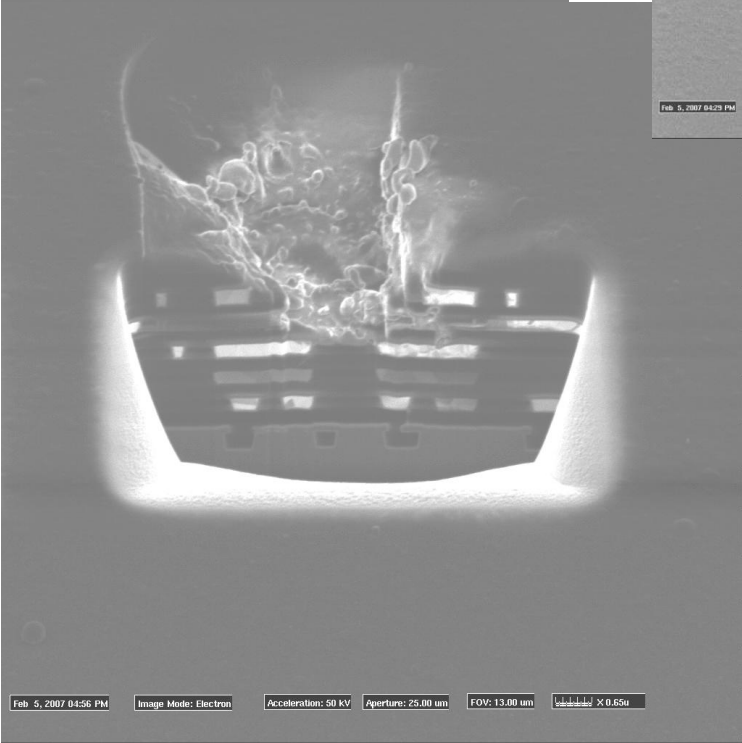
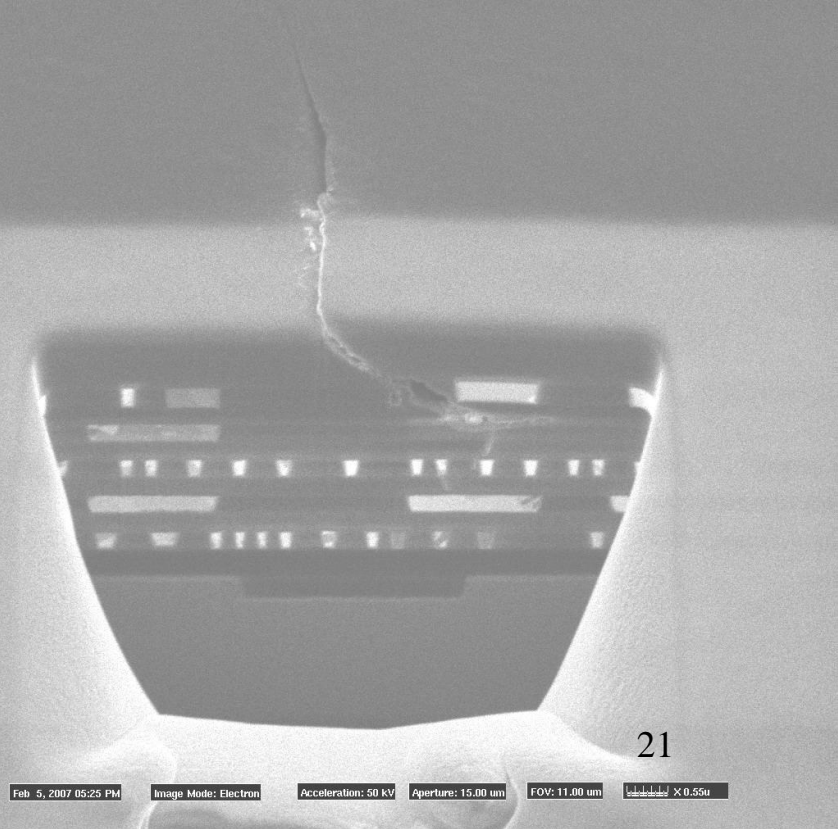
Medium degree of severity

the top1-2 metal layers are damaged

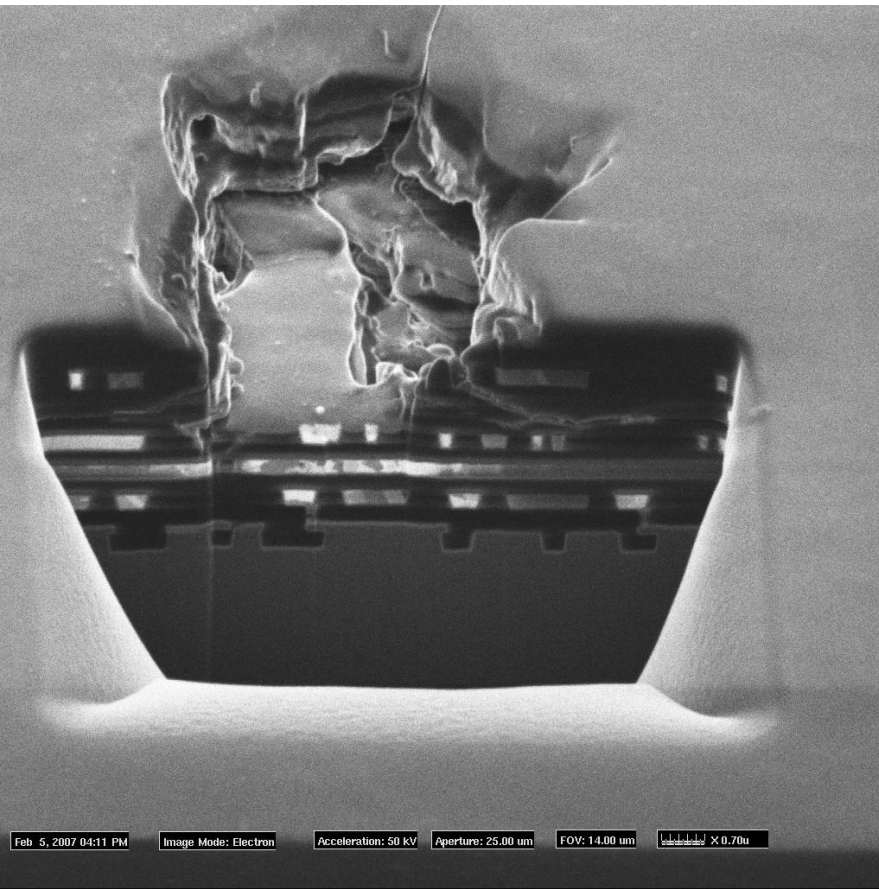
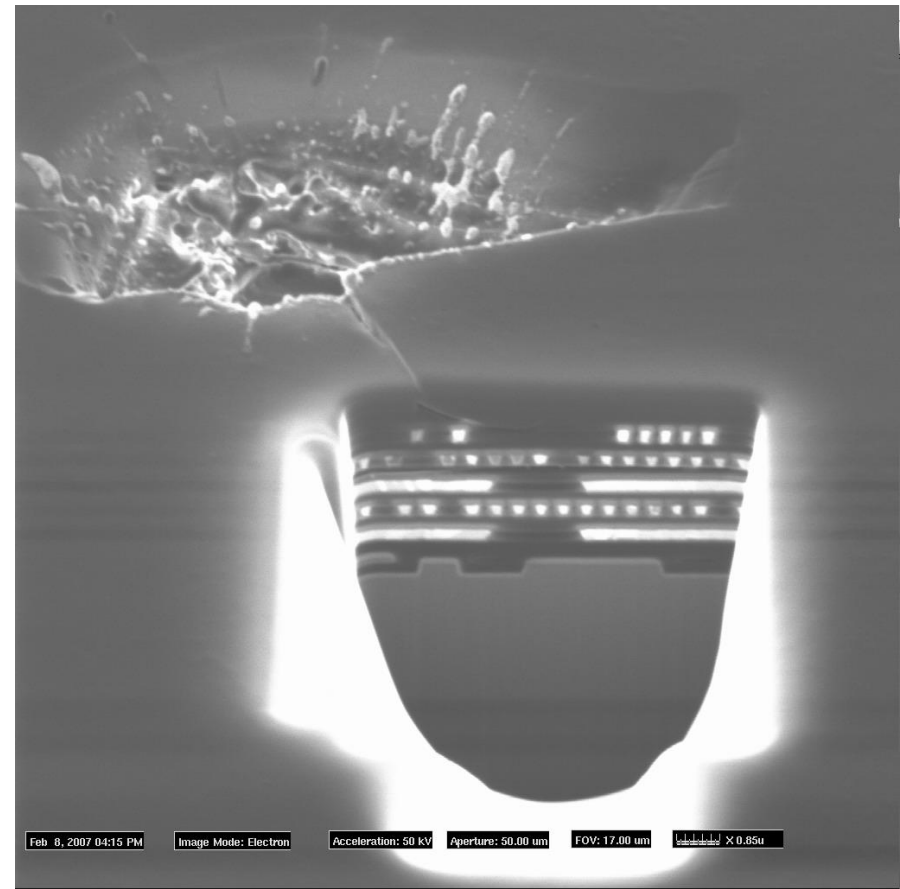
Severe degree of damage

Those damages involve deeper metal layers, too; sometimes "explosion-like" signature with strong horizontal components

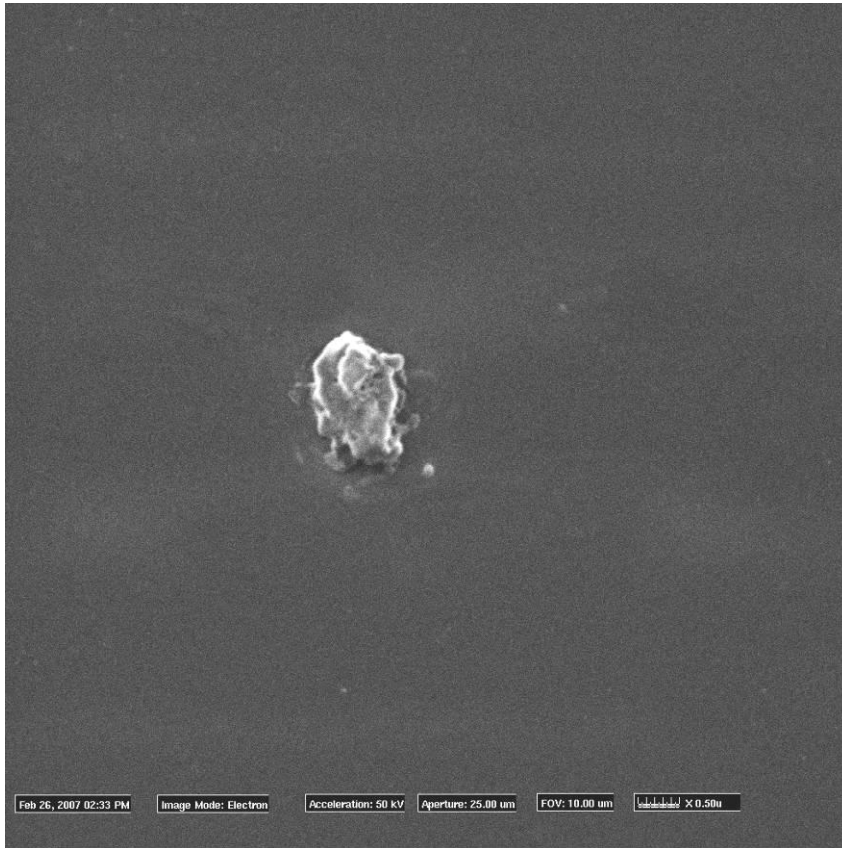
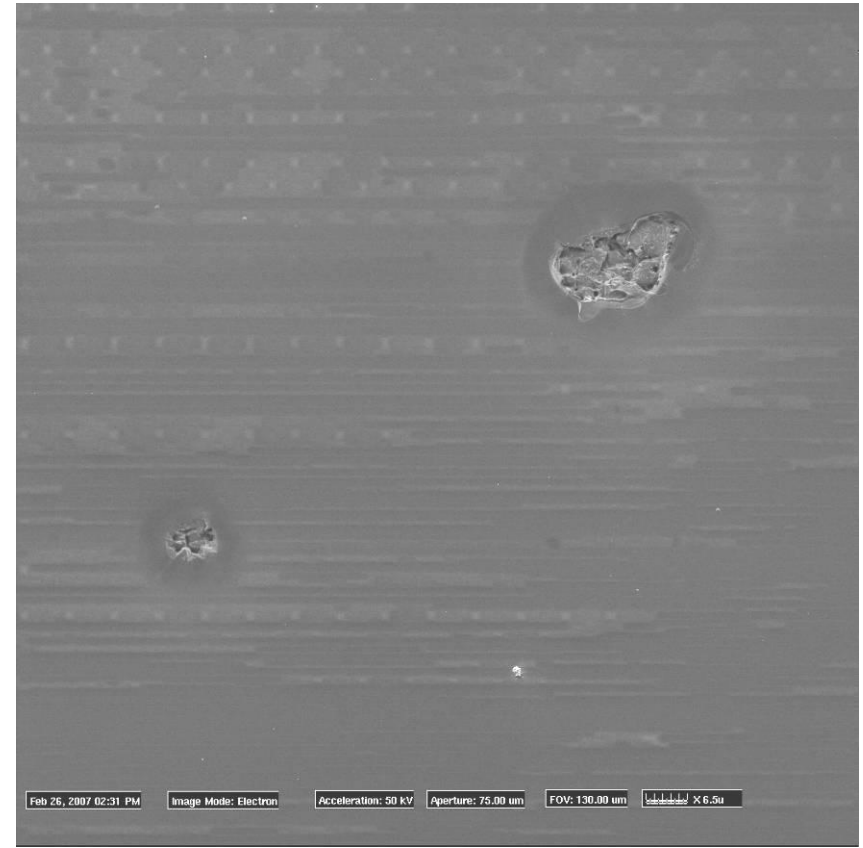
Particle embedding

Since particles are elevated on planar passivations, they serve as a prioritised target point for ESDFOS. ESDFOS fixes them by point-welding and, thus, mask the real ESDFOS impact.

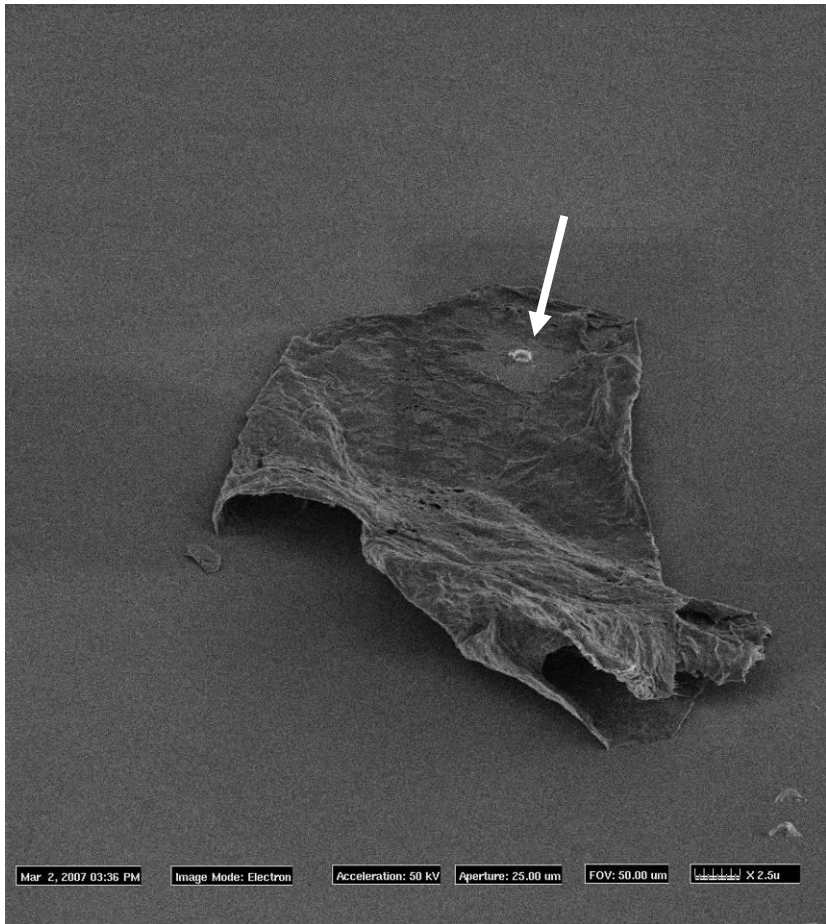
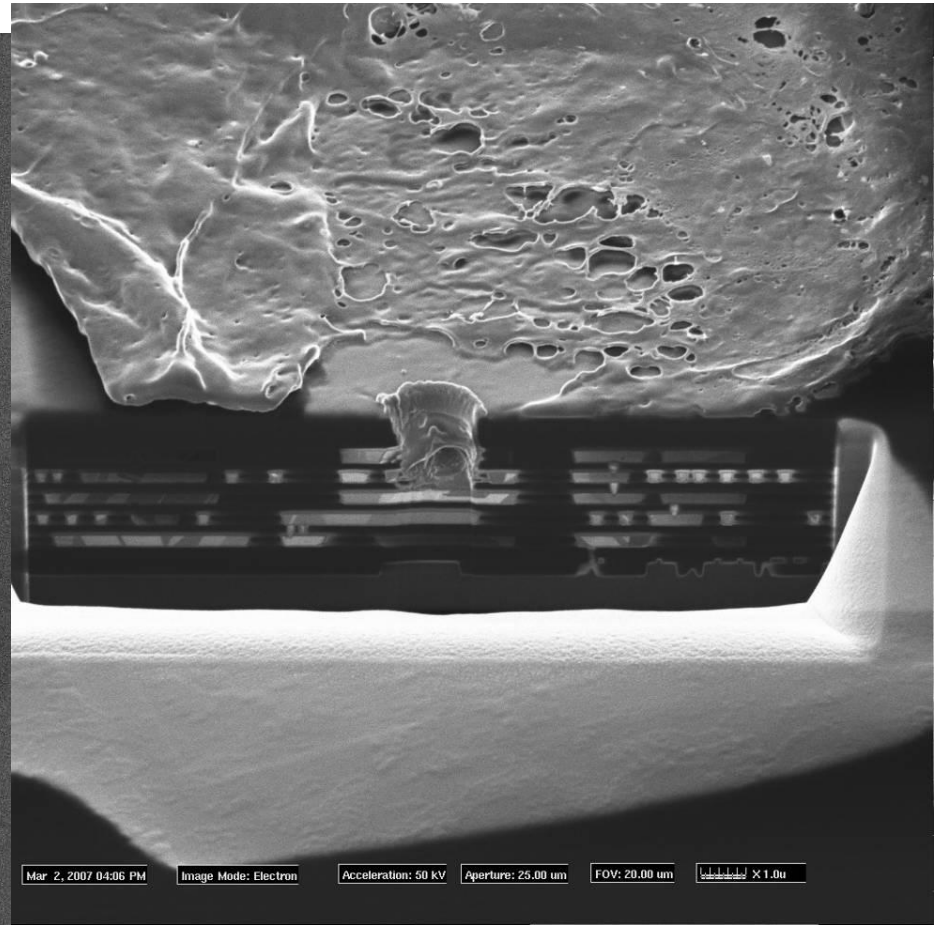
Fixing a pancake particle by ESDFOS welding

Nobody would assume ESDFOS when finding such a particle...

...however, a FIB-cross section proves exactly this (180° rotated, cross section through the ESDFOS impact hole
