ESD-related damage mechanisms in microelectronic devices

Peter Jacob

Overview about ESD damages caused by process robotics

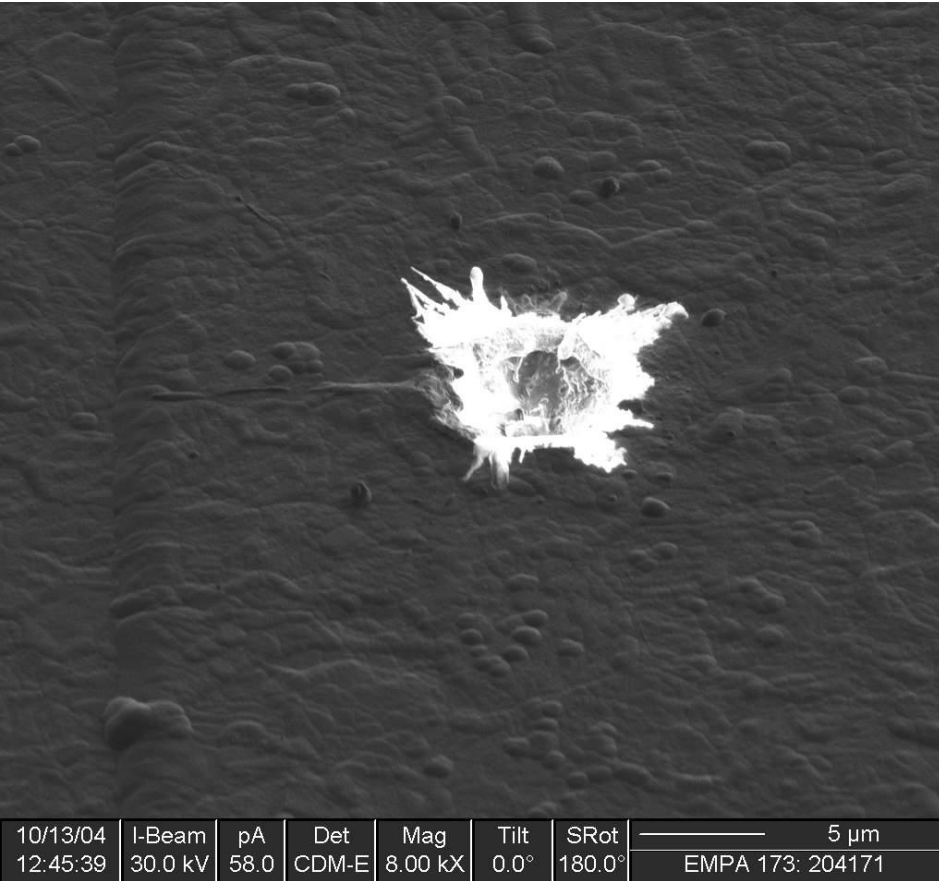
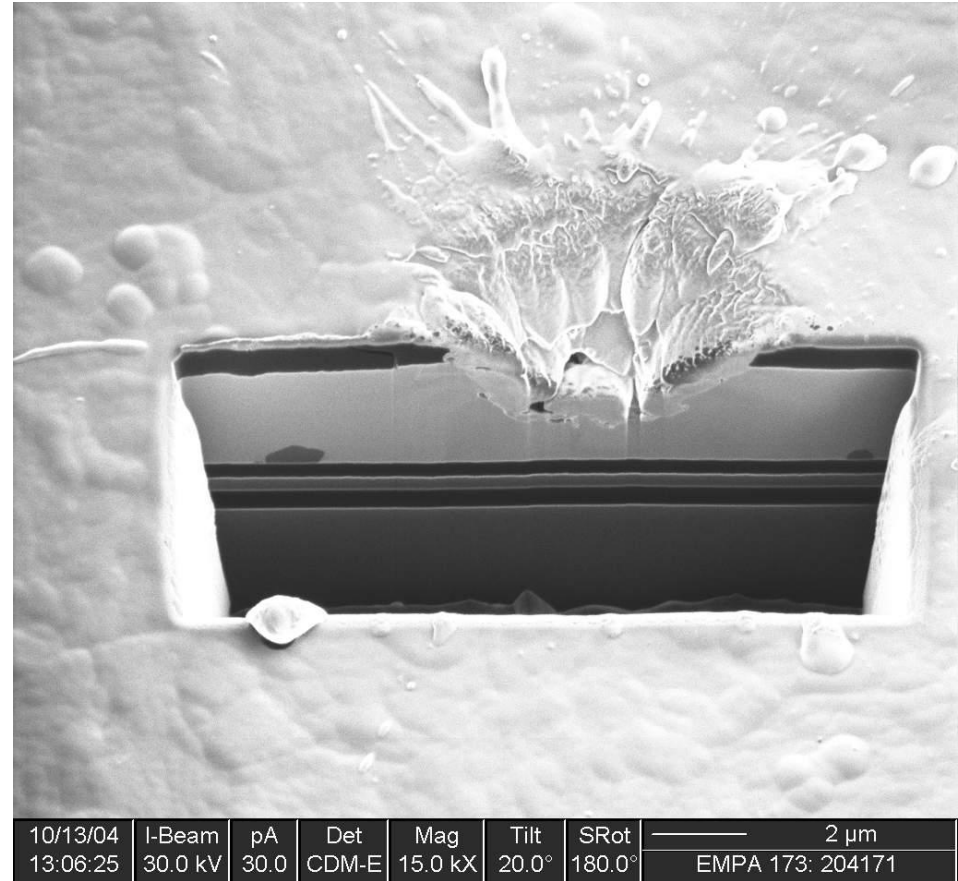
ESDFOS in IGBT-chip

ESDFOS impact in a *passivated region*. The impact melts material of the volume and throws it off, like a volcano. Both impact types (metal surface and passivated) don't cause direct structural damage like on microelectronic devices. Gate ox breakdown and/or p/n leakage may sometimes appear on distant locations instead.

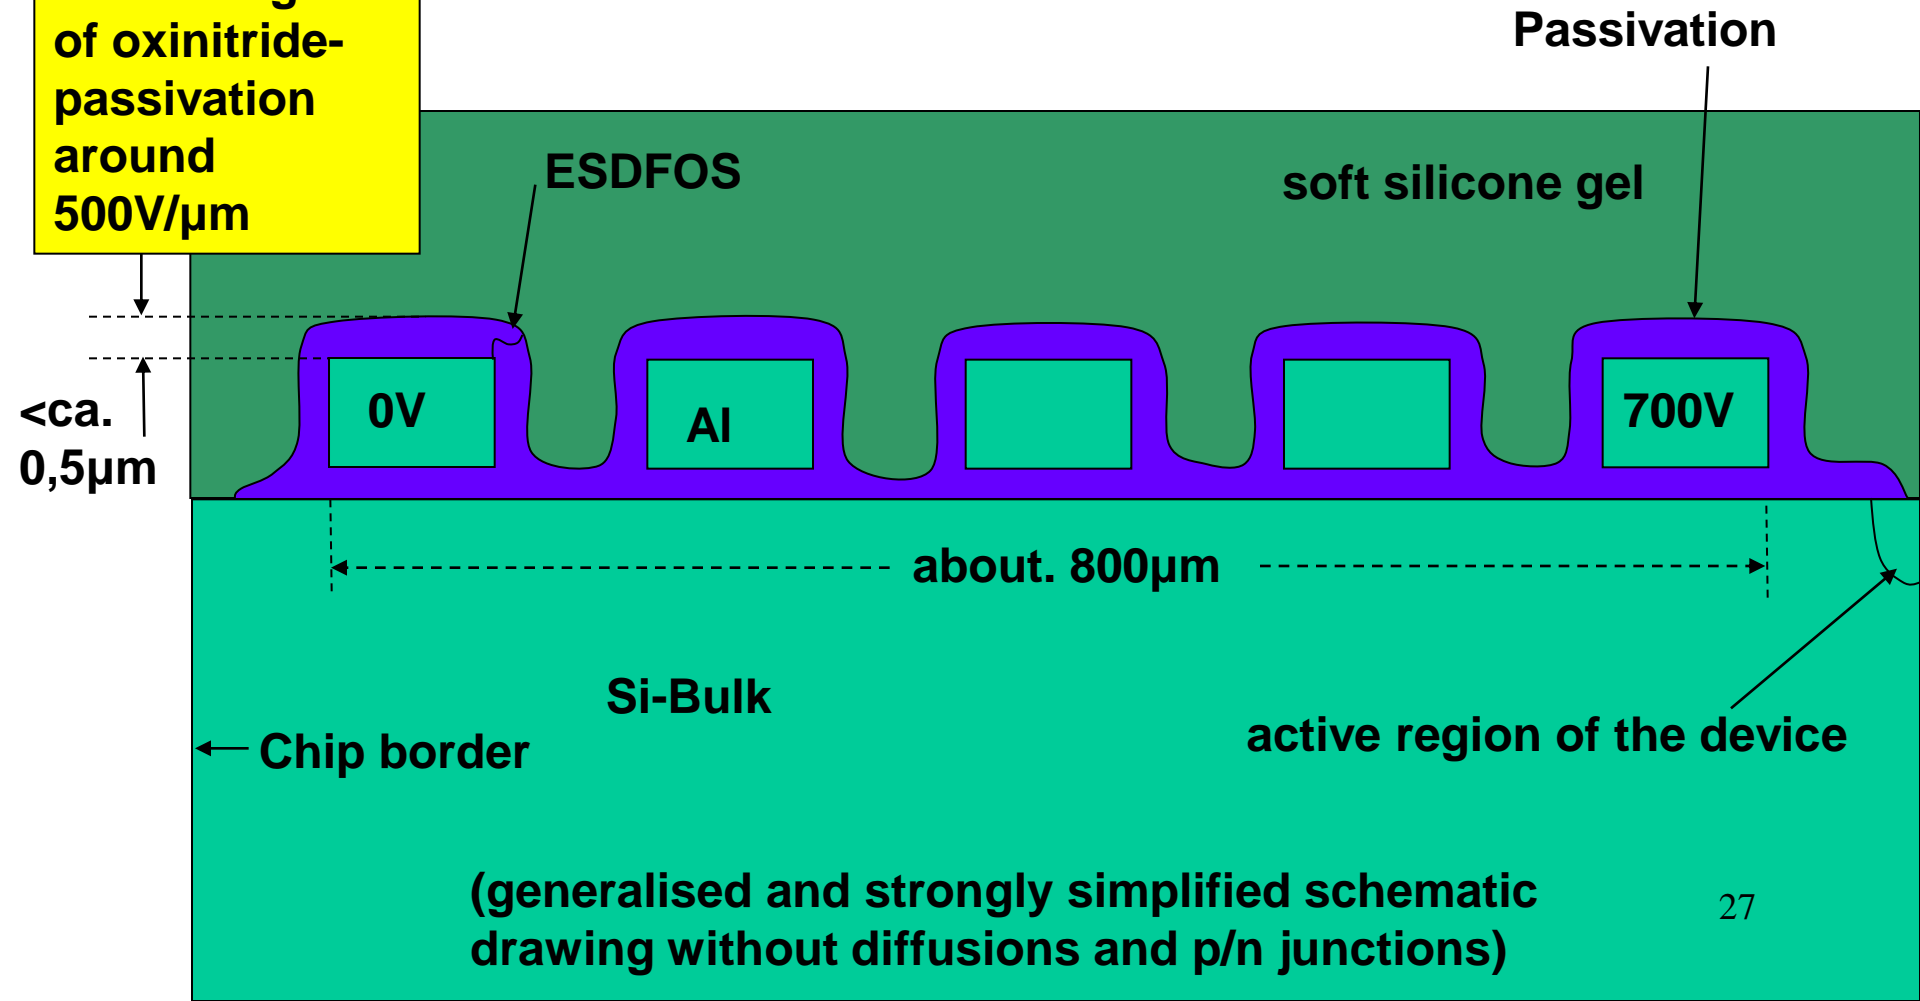
Cross section of a field plate ring border

If humidity-induced creeping current occurs at the bottom side of the soft silicone gel layer, a $< 0,5\mu\text{m}$ thick passivation cannot prevent a field-induced breakdown in case of a locally ESDFOS-pre-damaged passivation.

breakdown fieldstrength of oxinitride-passivation around $500\text{V}/\mu\text{m}$

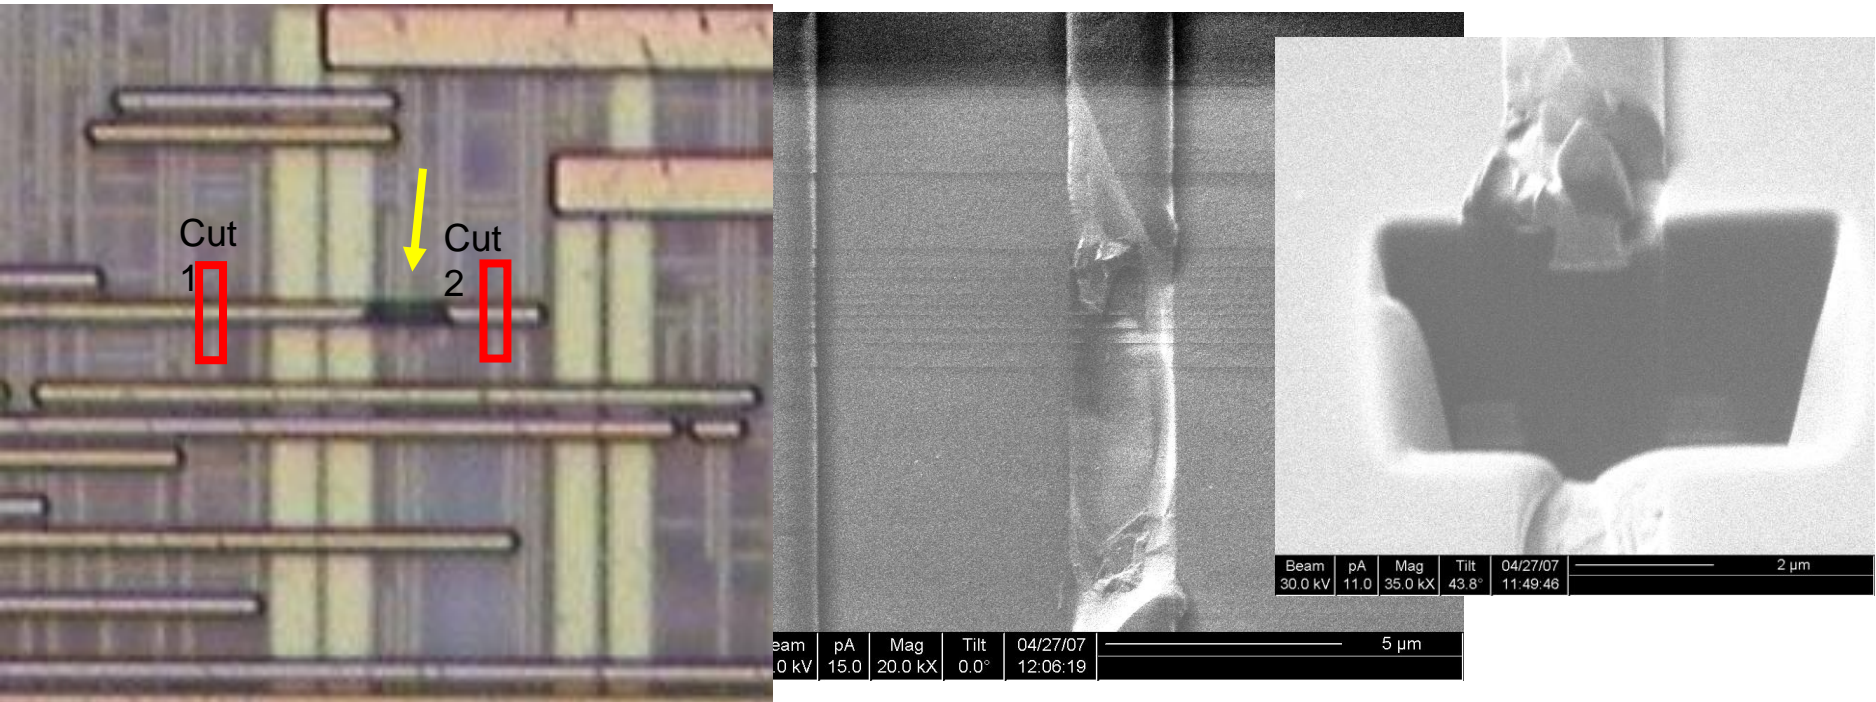
Mechanical metal spalling by ultrasonic force and/ or frontside detaping

Cavities induced by an „unintended ultrasonic cleaning“ during wafer sawing can generate ESDFOS-similar mechanical damage. Verification needs FIB-cross-sectioning, especially interlevel dielectric shorts and needle-like-aluminum-peaks are missing in such cases.

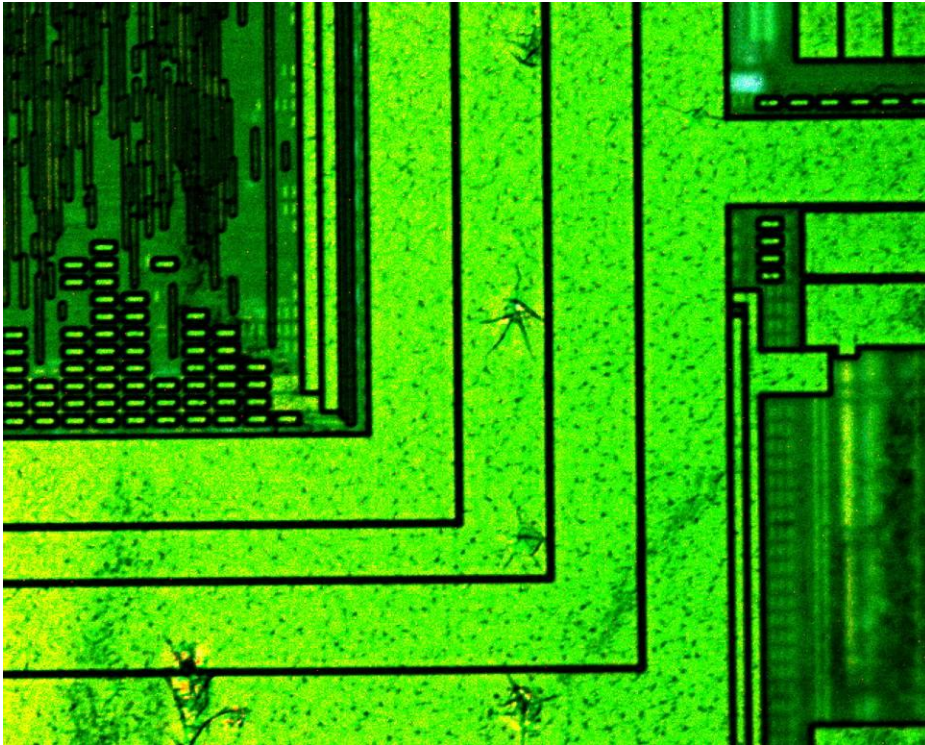
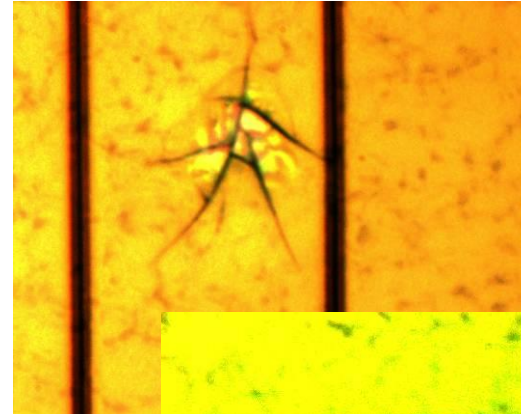
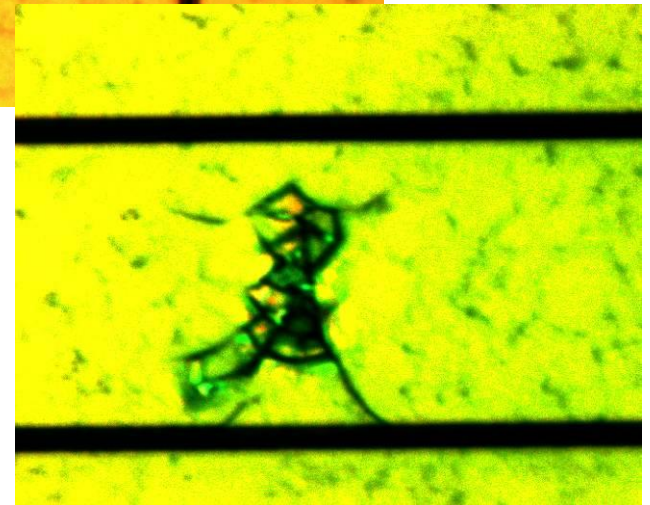
Ultrasonic Cleaning Induced Defects

Reproducible defects, originating from an ultrasonic cleaning bath with some days old DI-water. After water renewal, the defects could not be reproduced anymore

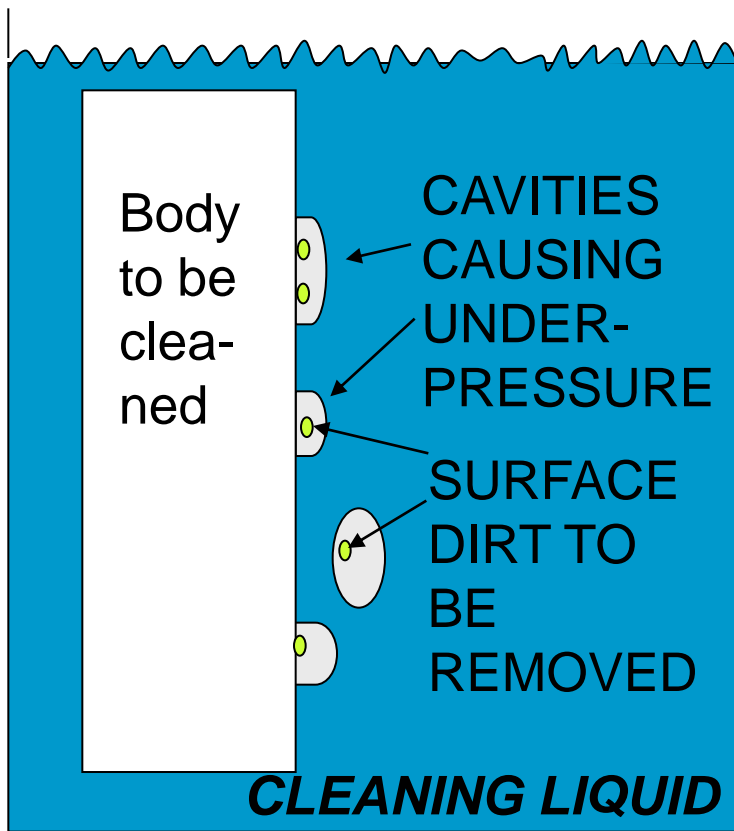
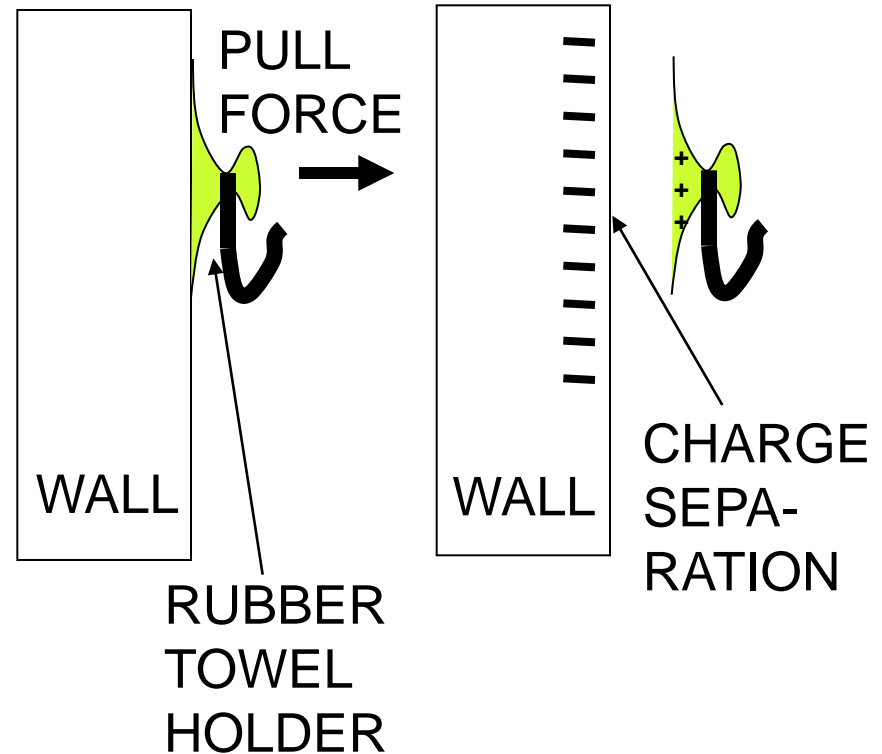
Ultrasonic Cleaning Effects

„Vacuum“ cavities clean the object (left) Under certain circumstances, ultrasonic cleaning may generate charging, too (right)
The wafer sawing process generates ultrasonic frequencies

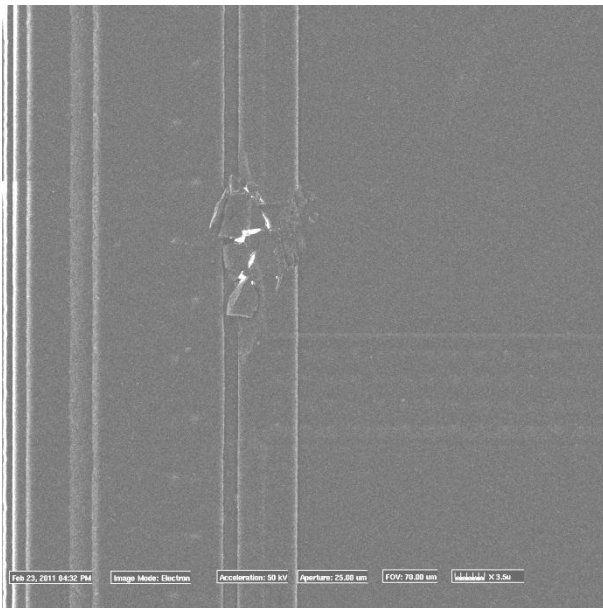
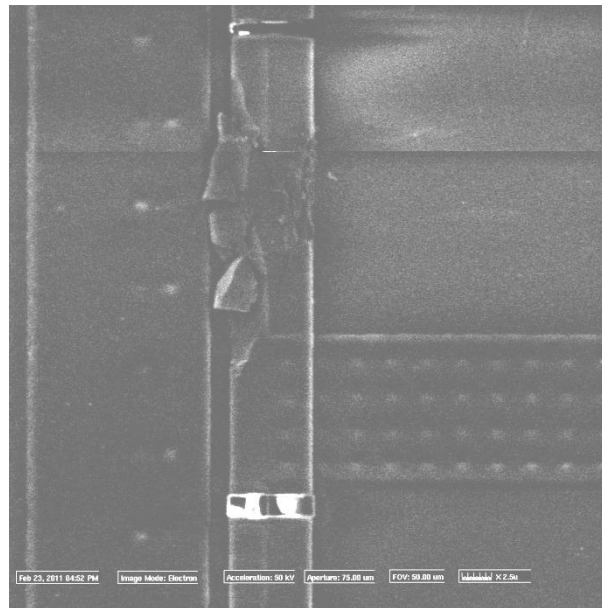
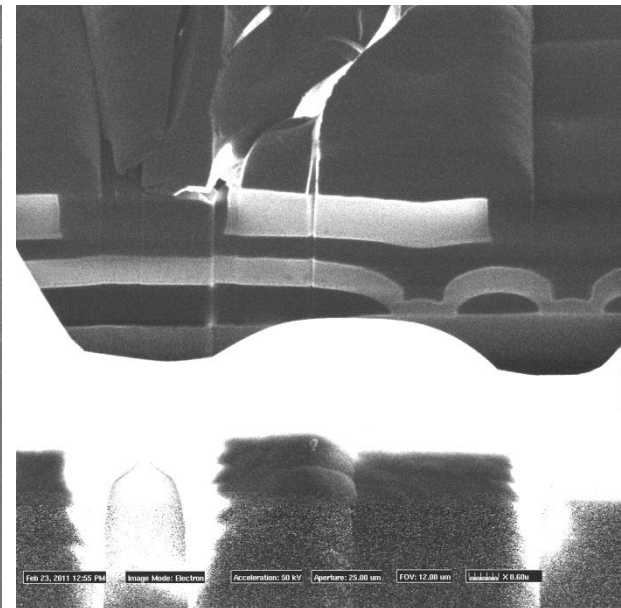
Pick&Place may cause similar non-ESDFOS damages, too !

ESDFOS-like looking damage, caused by a small Si-particle adheasing at the rubber-made picker head, which damaged the passivation. A passive potential-contrast examination (center) shows that the top metal is not electrically connected to the metal underneath, as it would be significant for ESDFOS
