ESD-related damage mechanisms in microelectronic devices

Peter Jacob

Overview about ESD damages caused by process robotics

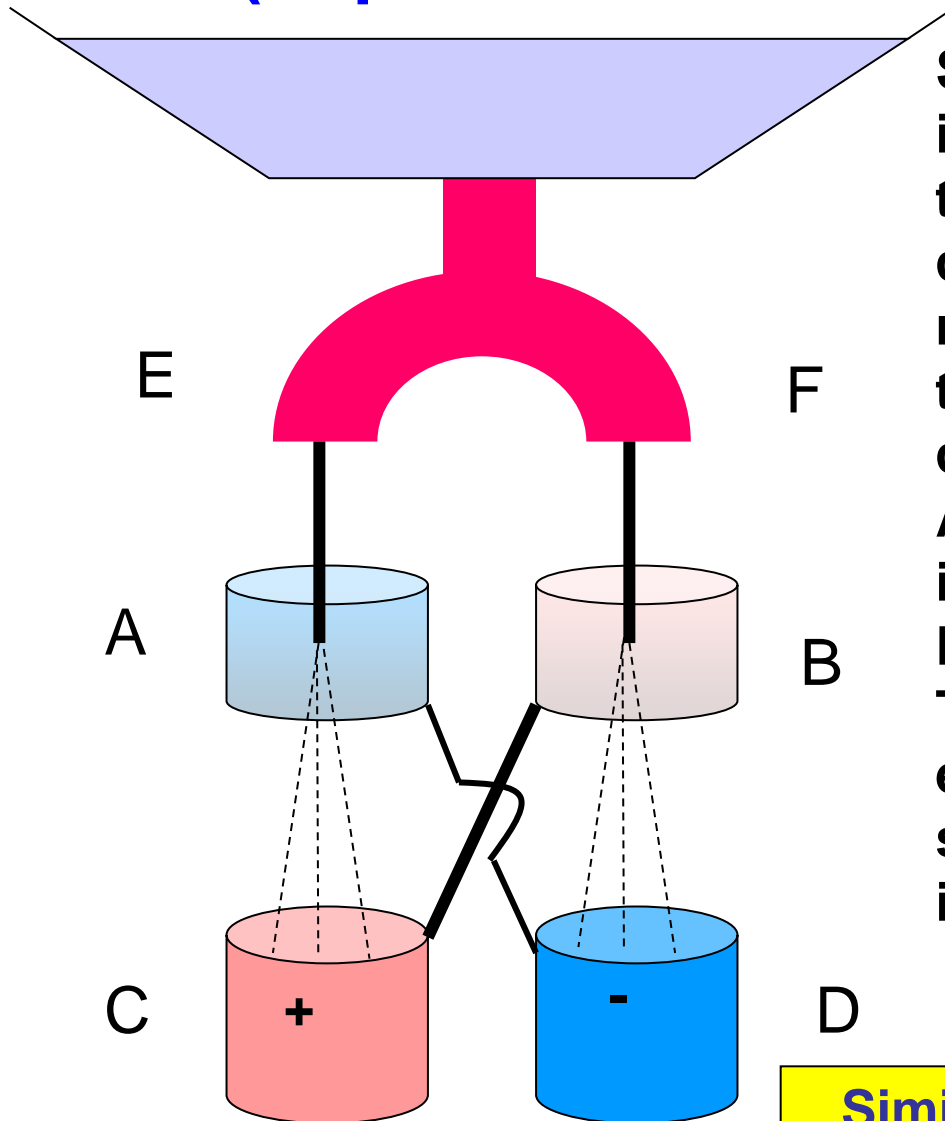
Electrostatic induction in a Kelvin generator (Experimental demo in the break)

Slightly different dropping rates in A and B generate a small potential difference between the collecting pots C and D, generating a horizontal E-Field between them. By means of cross-circuiting it, using the cylinders A and B, this E-field is converted into two vertical contradictory E-fields between A-C resp. B-D. These fields superimpose the earth E-field and amplify themselves rapidly by electrostatic induction feedback

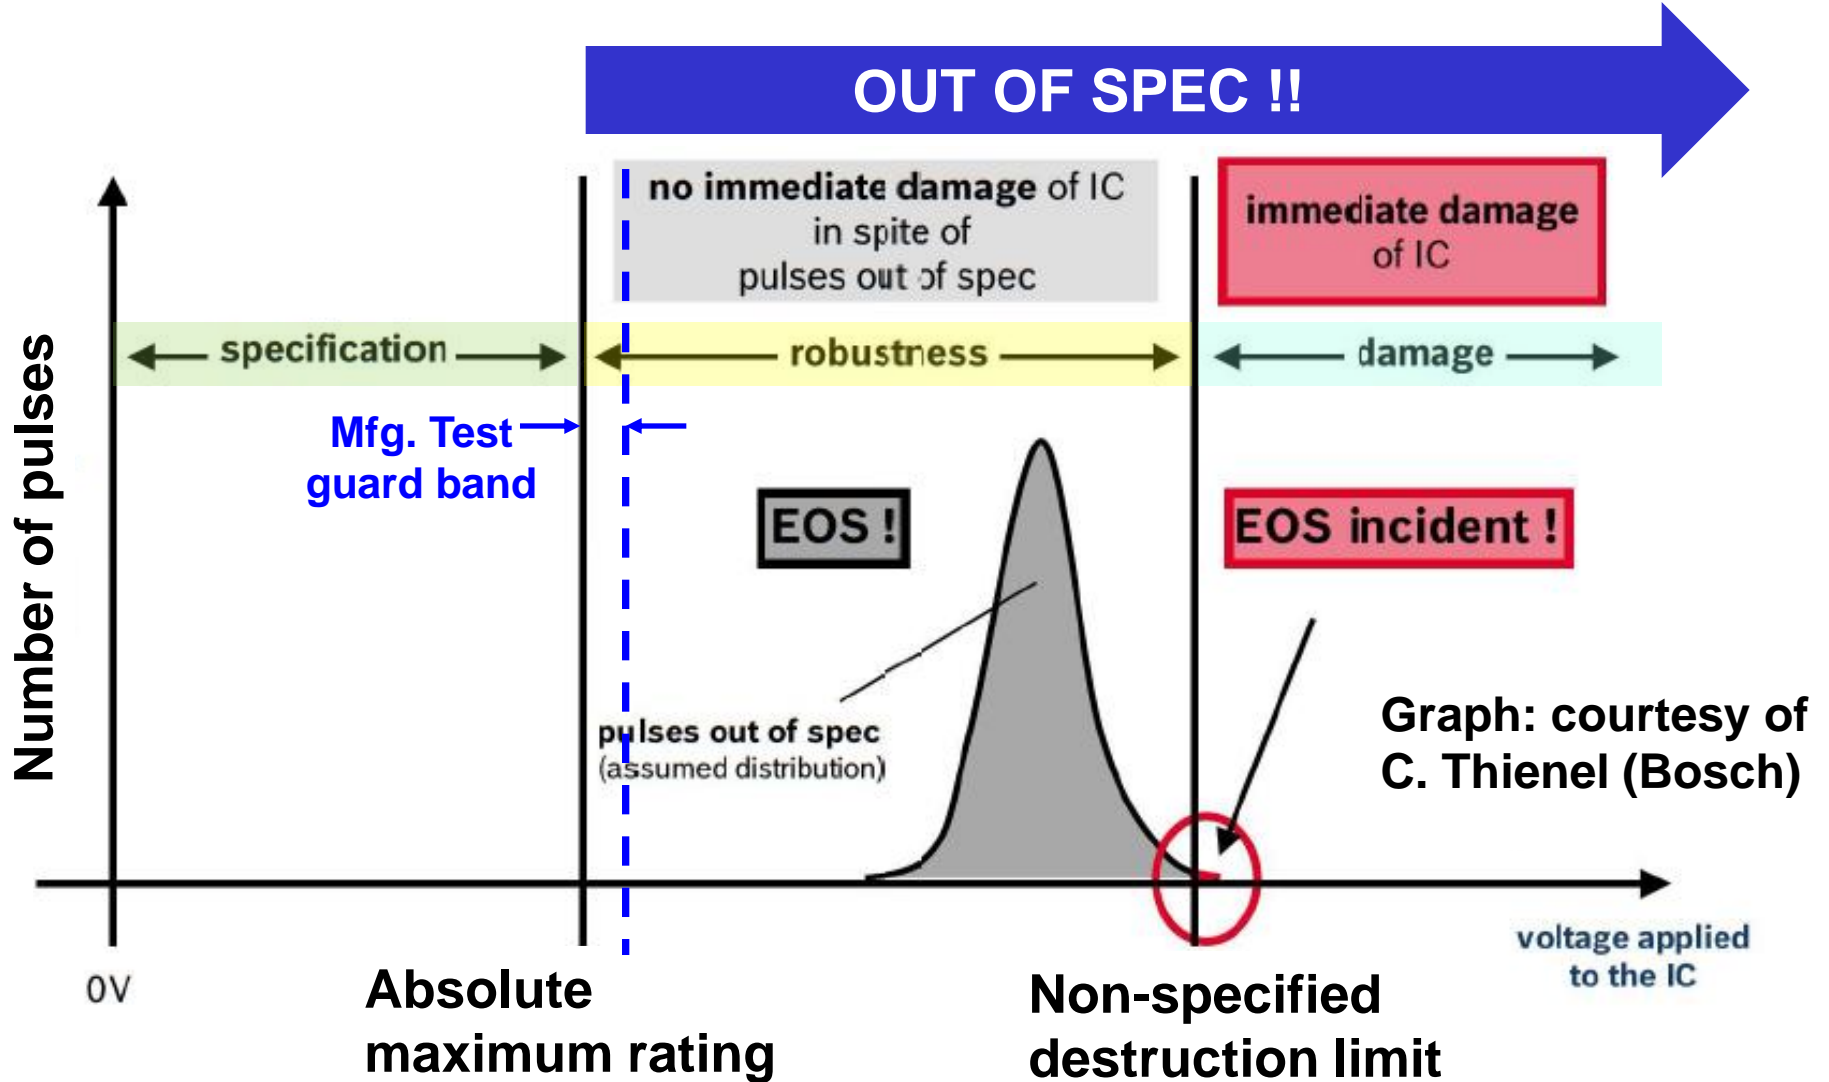
ESD/ EOS: Where starts EOS?

EOS starts beyond specifications!
