Research into the causes of the measured displacements of a quay wall

Abstract

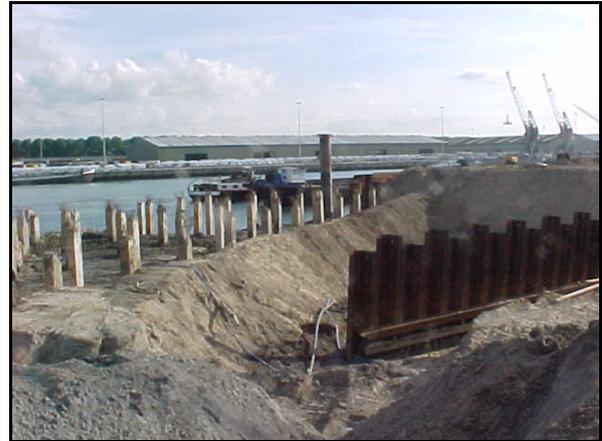
Fig. 4 Anchor wall and reused foundation piles

A second effect that is investigated is the capacity of the soil in front of the anchor wall, see figure 5. Insufficient anchor capacity results in additional deformation. Due to an improved passive soil wedge over 10 metres in front of the anchor wall, it was not very likely that the soil capacity was insufficient.

Based on calculations, it was concluded that this influence was negligible in relation to the measurements.
